**TUSCOLA COUNTY ROAD COMMISSION  
REQUEST FOR PROPOSAL  
PROFESSIONAL ENGINEERING AND BRIDGE DESIGN SERVICES  
Dutcher over Northwest Drain Bridge Design  
Letting Date: **February 29, 2024 8:30am**  
**Addendum 001****

**Structure No 10471, Dutcher Road over the Northwest Drain, Gilford Township**

**BRIDGE SAFETY INSPECTION REPORT**

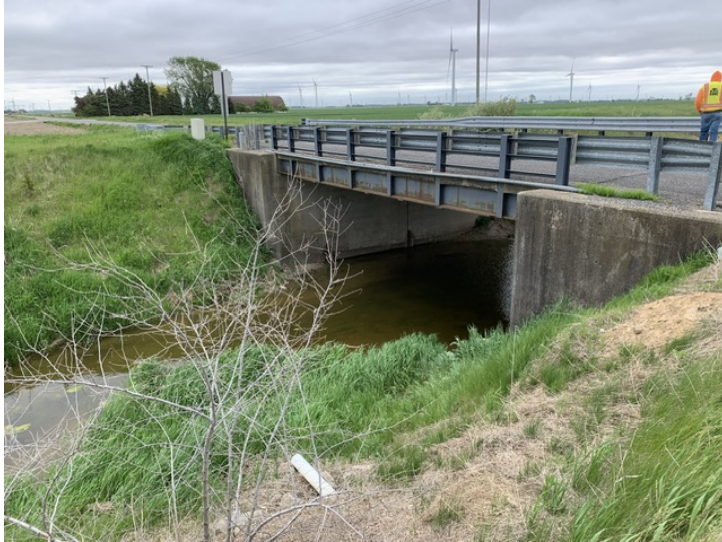
Document Name: IMG\_2327.jpeg  
Category: Elevation  
Span Number:  
Comments: North elevation

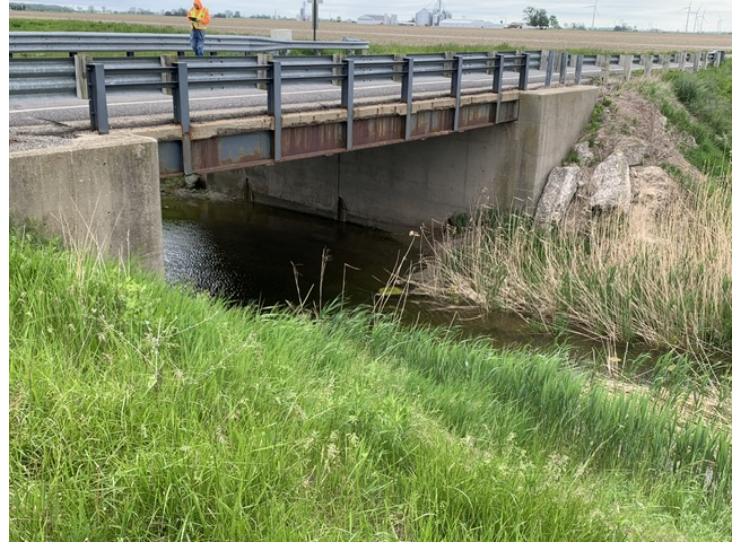
Document Name: IMG\_2329.jpeg  
Category: Elevation  
Span Number:  
Comments: South elevation

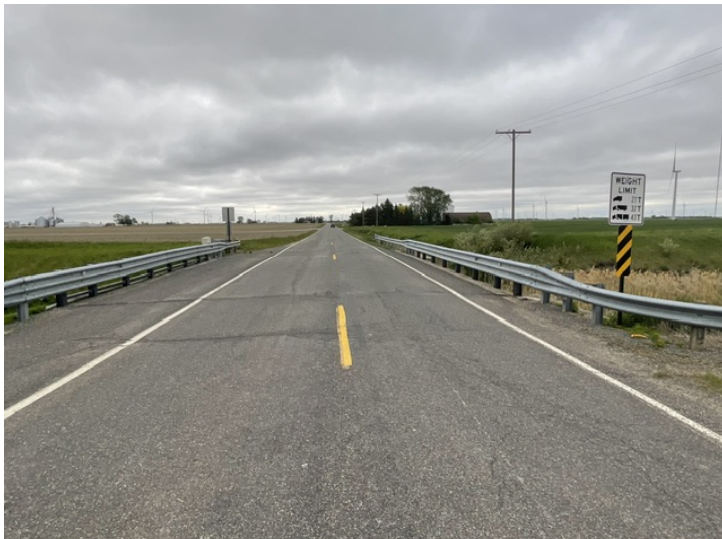
Document Name: IMG\_9436.jpeg  
Category: Posting  
Span Number:  
Comments: Posting sign at west end of structure

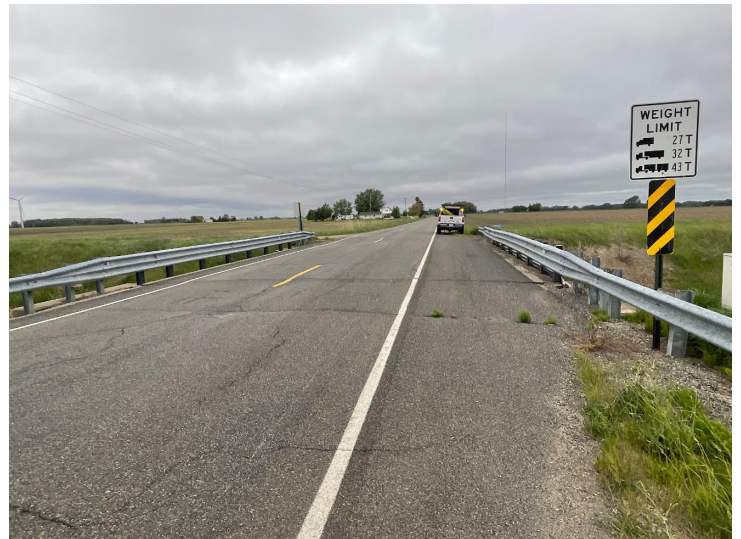
Document Name: IMG\_9440.jpg  
Category: Posting  
Span Number:  
Comments: Posting sign at east end of structure

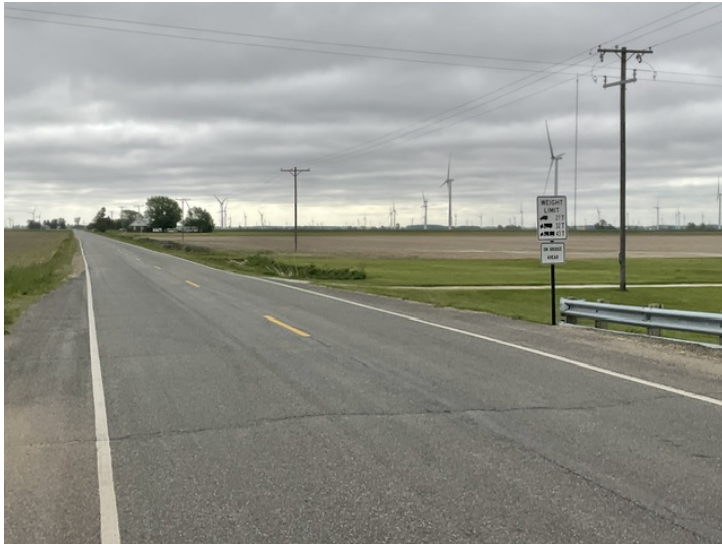
Document Name: IMG\_9454.jpeg  
Category: Posting  
Span Number:  
Comments: Advanced posting sign west of structure

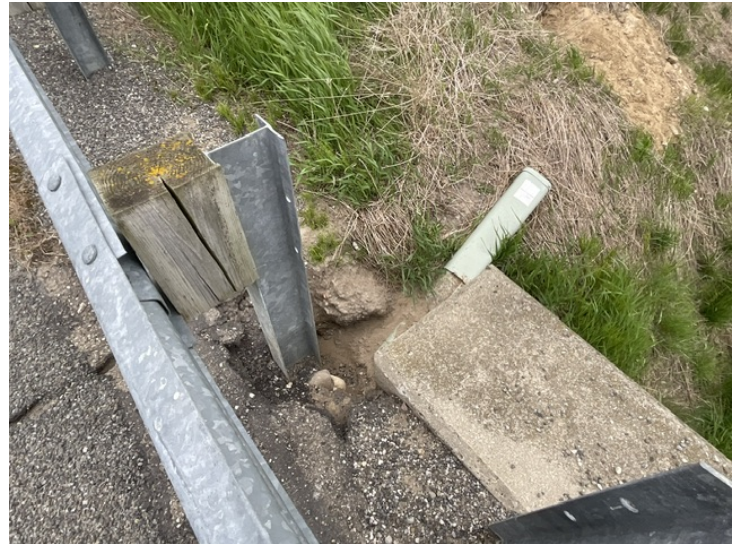
Document Name: IMG\_9437.jpeg  
Category: Railing  
Span Number:  
Comments: Post 1W, north railing

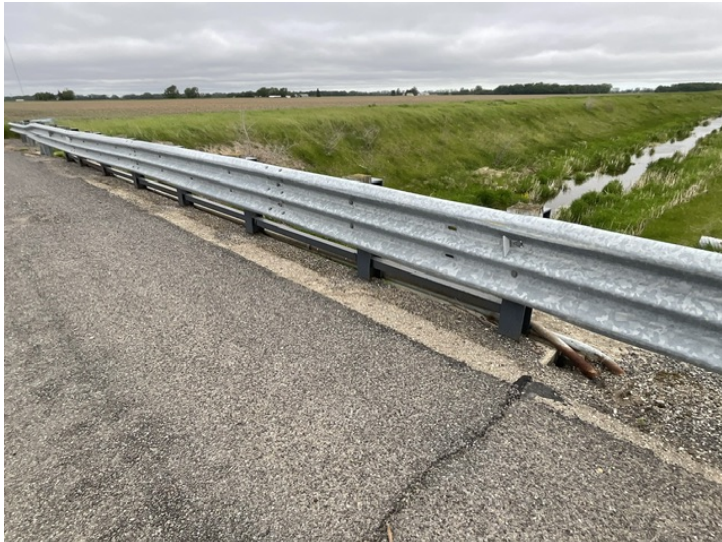
Document Name: IMG\_9444.jpeg  
Category: Railing  
Span Number:  
Comments: Railing, typical

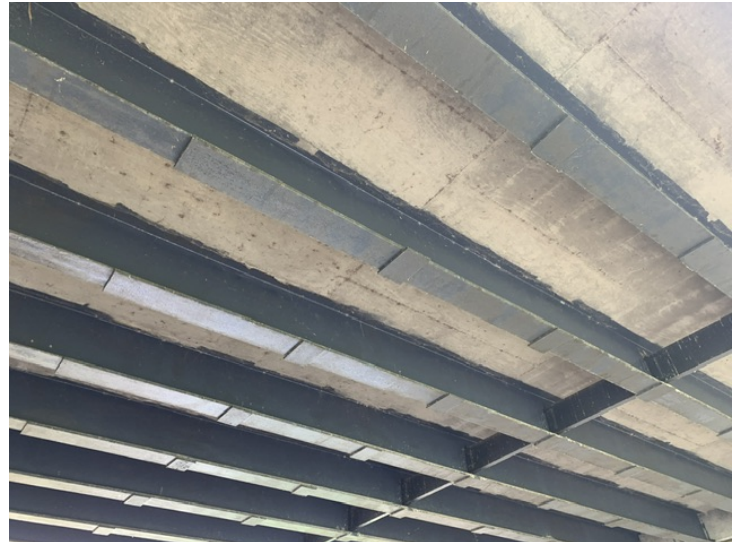
Document Name: IMG\_2331.jpeg  
Category: Deck  
Span Number:  
Comments: Concrete deck bottom surface

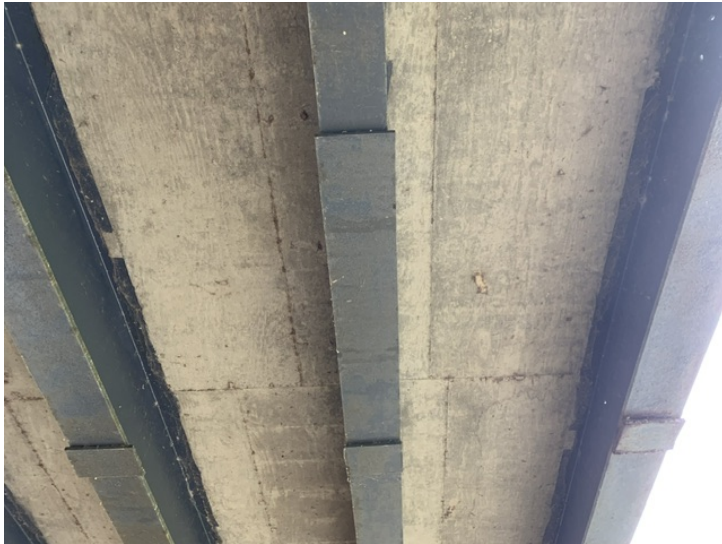
Document Name: IMG\_2333.jpeg  
Category: Deck  
Span Number:  
Comments: Concrete deck bottom surface

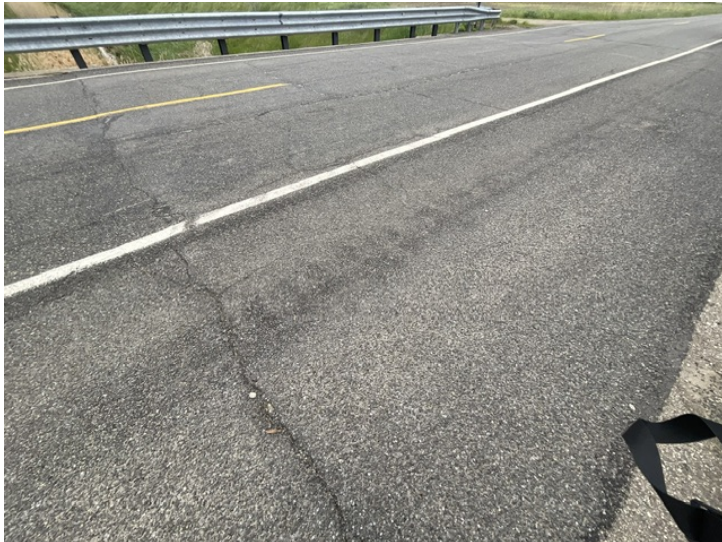
05/19	05/21	05/23	
<b>1. Surface (SIA-58A)</b>	5	6	6	HMA surface with chip seal application. Open transverse/longitudinal cracks up to 3/4 inches wide spaced 5' apart. Deep longitudinal crack along westbound, partially sealed. (05/23) Chip seal. Open transverse/longitudinal cracks spaced 5' apart. Deep longitudinal crack along westbound, partially sealed. (05/21) Chip seal. Open transverse/longitudinal cracks; deep longitudinal crack along westbound (05/19)
<b>2. Expansion Joints</b>	5	N	N	End joints have been paved over. Reflective cracking above each reference line partially sealed with chip seal application. (05/23) End joints have been paved over; partially sealed transverse cracks (05/21) Paved over; partially sealed transverse cracks (05/19)
<b>3. Other Joints</b>	N	N	N	(05/23) (05/21) (05/19)
<b>4. Railings</b>	7	7	7	Steel I-post barriers with two steel angle beams on the south and three steel angle beams on the north side of structure. Thrie beam retrofit has been placed in front of old barrier system with wood offset blocks. Light rust on railing posts. (05/23) Steel I-post barriers with two steel angle beams on the south and three steel angle beams on the north side of structure. Thrie beam retrofit has been placed in front of old barrier system. Light rust on railing posts. (05/21) Steel I-post barriers with two steel angle beams on the south and three steel angle beams on the north side of structure. Thrie beam retrofit has been placed in front of old barrier system. Light rust on railing posts. (05/19)

Document Name: IMG\_9442.jpeg  
Category: Deck  
Span Number:  
Comments: Chip sealed HMA surface

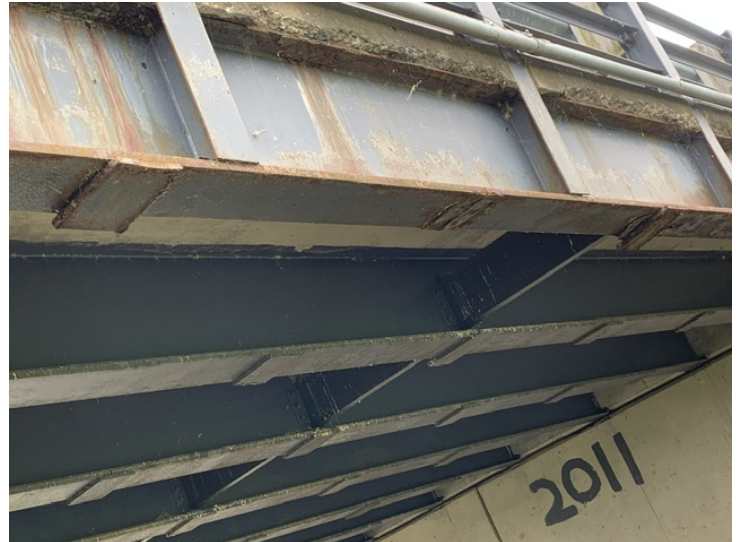
**9. Stringer (SIA-59)**      5      5      5      (10) Steel I-beams with square end cover plates. Cover plates applied in 4' +/- sections in 1990. Steel channel diaphragms at midspan. Splice Plates for cover plates loose and rusty at beam 1s and 10s. Missing splice plates 3w at south fascia beam and 4w at north fascia beam. Several tack welds at cover plate splices. Beam 1S, 6S and 10S have pairs of drilled holes through webs, (6) pairs per beam. Painted over pitting evident in some locations. Rust forming at beam ends. Paint degradation and surface rust covers 60% of the outside of south fascia beam and 15% of the outside of north fascia beam. (05/23)  
 10 steel I-beams with square end cover plates applied in 4' +/- sections in 1990. Steel channel diaphragms at midspan. Splice Plates for cover plates loose and rusty at beam 1s and 10s. Missing splice plates 3w at south fascia beam and 4w at north fascia beam. Several tack welds at cover plate splices. Beam 1S, 6S and 10S have pairs of drilled holes through webs, (6) pairs per beam. Painted over pitting evident in some locations. Rust forming at beam ends. Paint failure and surface rust covers 60% of the outside of south fascia beam and 15% of the outside of north fascia beam. (05/21)

Document Name: IMG\_2334.jpeg  
Category: Superstructure  
Span Number:  
Comments: Steel I-beams

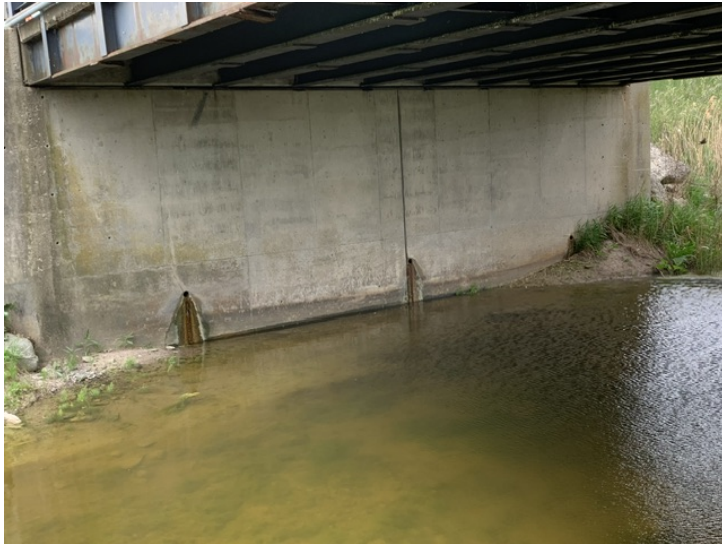
05/19	05/21	05/23	
<b>13. Abutments (SIA-60)</b>	7	7	7	Concrete cantilever abutment walls. Minor hairline cracks above weep holes. There are three 2" diameter weep holes per wall. (05/23) Concrete abutment walls. Minor hairline cracks off weep holes. There are three 2" diameter weep holes per wall. (05/21) Concrete abutment walls. Minor hairline cracks off weep holes. There are three 2" diameter weep holes per wall. (05/19)
<b>14. Piers (SIA-60)</b>	N	N	N	(05/23) (05/21) (05/19)
<b>15. Slope Protection</b>	N	N	N	(05/23) (05/21) (05/19)
<b>16. Channel (SIA-61)</b>	7	6	6	Flow south to north. Improved county drain with grass banks. Sloughing banks upstream and downstream of bridge. Entire channel is heavily vegetated at the south end. (05/23) Flow south to north. Improved county drain with grass banks. Sloughing banks upstream and downstream of bridge. Entire channel is heavily vegetated at the south end. (05/21) Flow south to north. Improved county drain with grass banks. Sloughing banks upstream and downstream of bridge. (05/19)

Document Name: IMG\_2328.jpeg  
Category: Substructure  
Span Number:  
Comments: East abutment

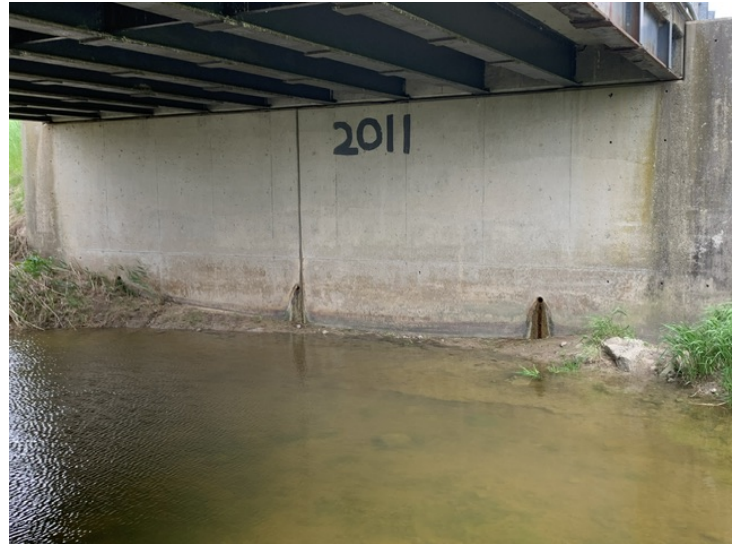
Document Name: IMG\_2330.jpeg  
Category: Substructure  
Span Number:  
Comments: West abutment

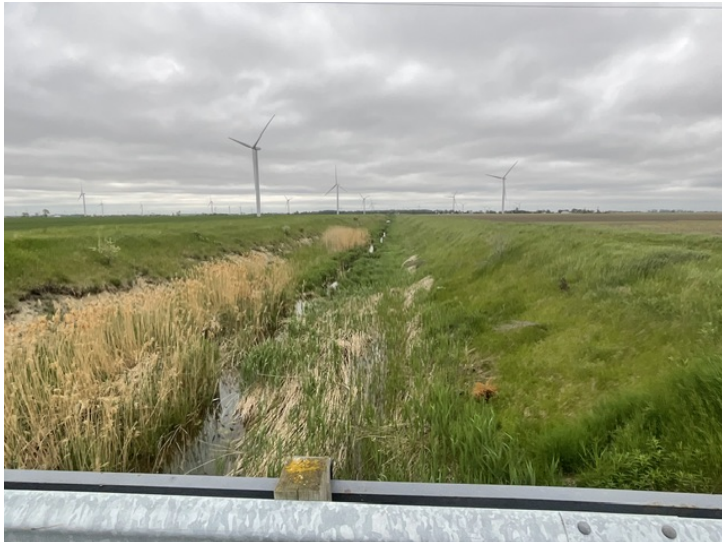
Document Name: IMG\_9438.jpeg  
Category: Channel  
Span Number:  
Comments: Looking south off structure

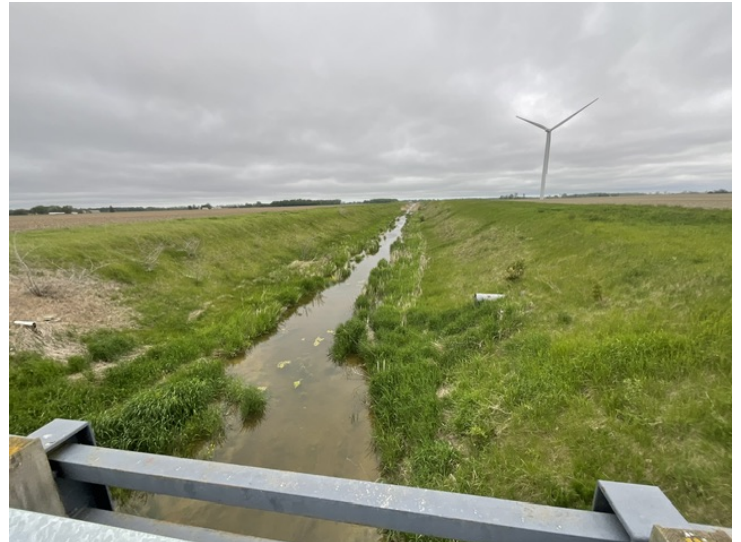
Document Name: IMG\_9443.jpeg  
Category: Channel  
Span Number:  
Comments: Looking north off structure

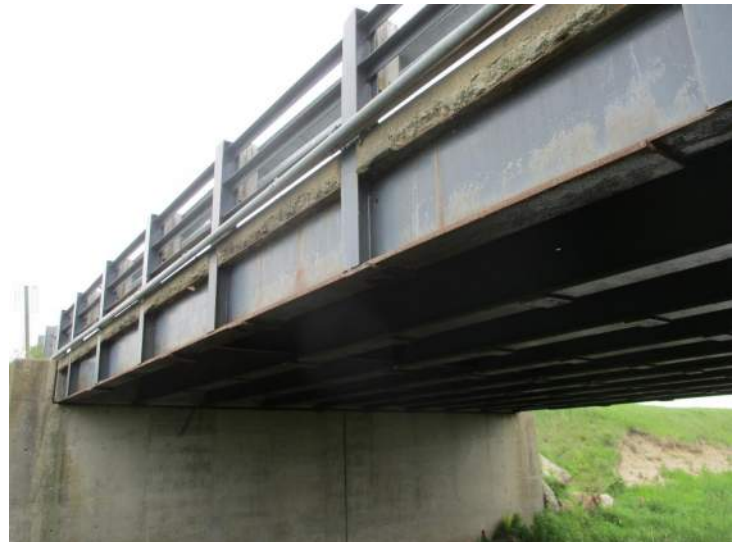
**7. Deck (SIA-58)**      6      6      6      Deck surface: HMA surface with chip seal application. Open transverse/longitudinal cracks up to 3/4 inches wide spaced 5' apart. Deep longitudinal crack along westbound, partially sealed. Deck bottom: Concrete deck. No deficiencies noted. Fascia: Both north and south fascia spalled 35'. (05/23)  
 Deck surface: Chip seal. Open transverse/longitudinal cracks spaced 5' apart. Deep longitudinal crack along westbound, partially sealed. Deck bottom: Concrete bottom surface, no deficiencies noted. Fascia: Both north and south fascia spalled 35'. (05/21)  
 Deck surface: Chip seal. Open transverse/longitudinal cracks; deep longitudinal crack along westbound. Deck bottom: Concrete bottom surface, no deficiencies noted. Fascia: south - 15' spalling; north - 35' spalling (05/19)

Document Name: 91.JPG  
Category: Elevation  
Span Number:  
Comments: South fascia, spalling

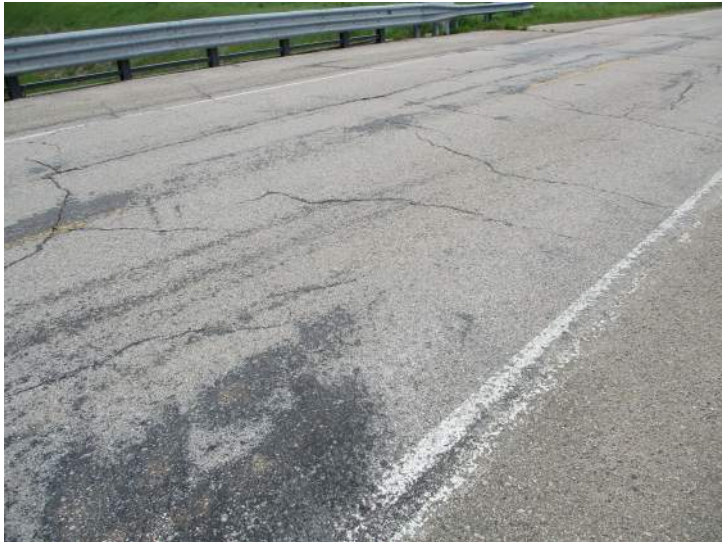
Document Name: 76.JPG  
Category: Approach  
Span Number:  
Comments: Deck surface

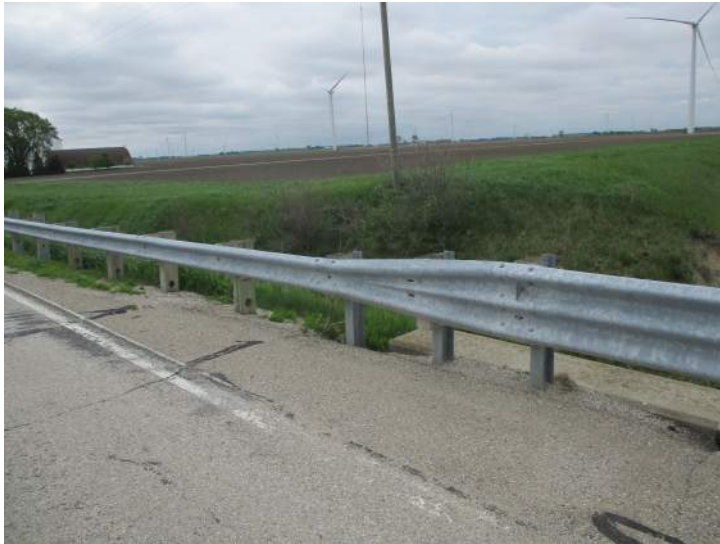
<b>20. Approach Slopes</b>				Some large pieces of broken concrete along return wingwalls in all four quadrants, mostly along south end. 1 on 2 grass covered slopes with a minor slumped bank in the southeast quadrant. Approach guardrail: thrie beam / type B. No impact damage. (05/23) Some large pieces of broken concrete along return wingwalls in all four quadrants. 1 on 2 grass covered slopes with a minor slumped bank in the southeast quadrant. Approach guardrail: thrie beam / type B. No impact damage. (05/21) Some large pieces of broken concrete along return wingwalls in all four quadrants. 1 on 2 grass covered slopes with a minor slumped bank in the southeast quadrant. Approach guardrail: thrie beam / type B. No impact damage. (05/19)

Document Name: 81.JPG  
Category: Approach  
Span Number:  
Comments: Southeast approach guardrail

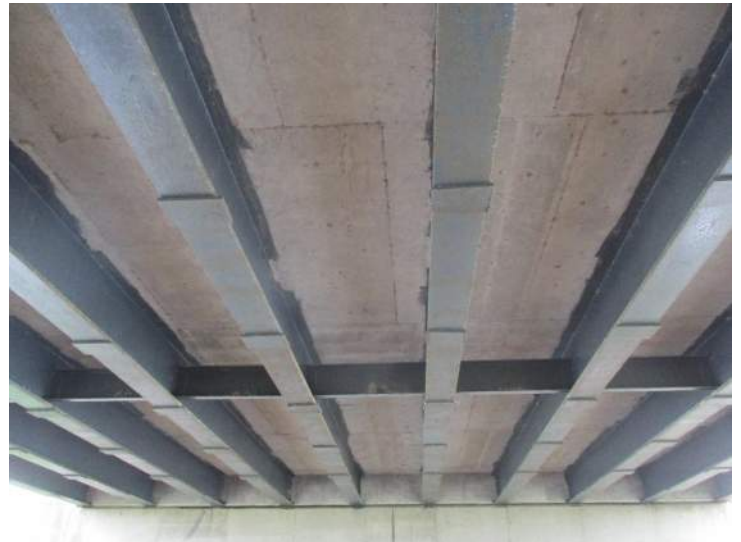
Document Name: 88.JPG  
Category: Deck  
Span Number:  
Comments: Deck bottom

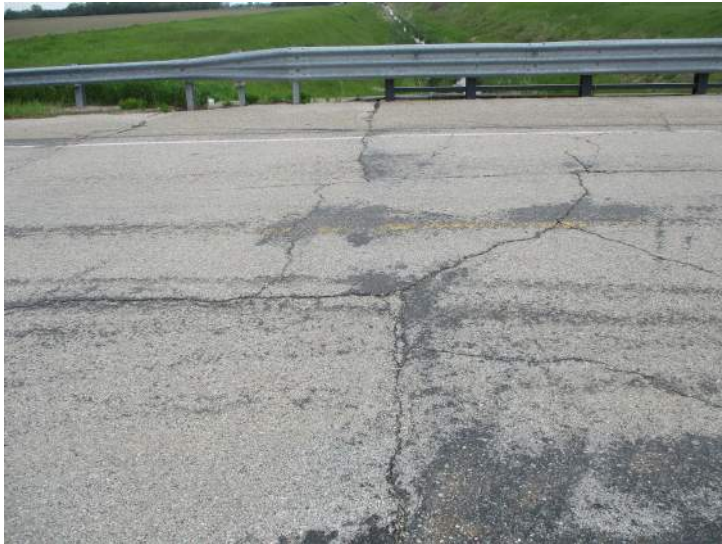
Document Name: 75.JPG  
Category: Joints  
Span Number:  
Comments: West end joint

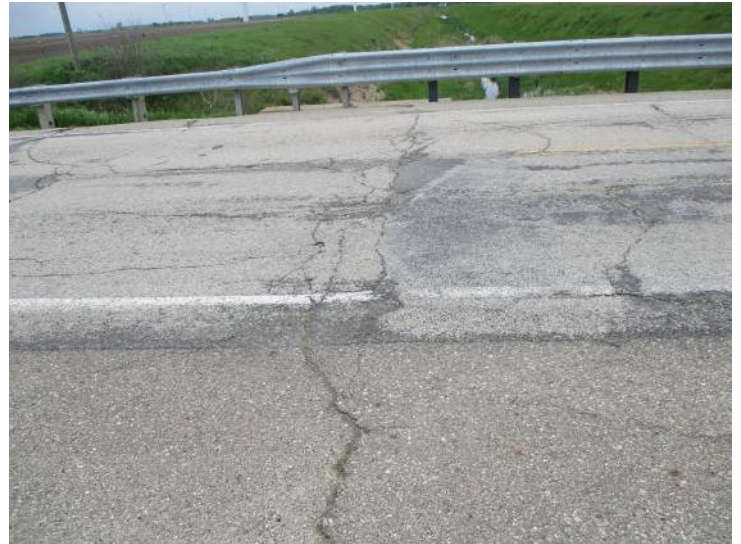
Document Name: 79.JPG  
Category: Joints  
Span Number:  
Comments: East end joint

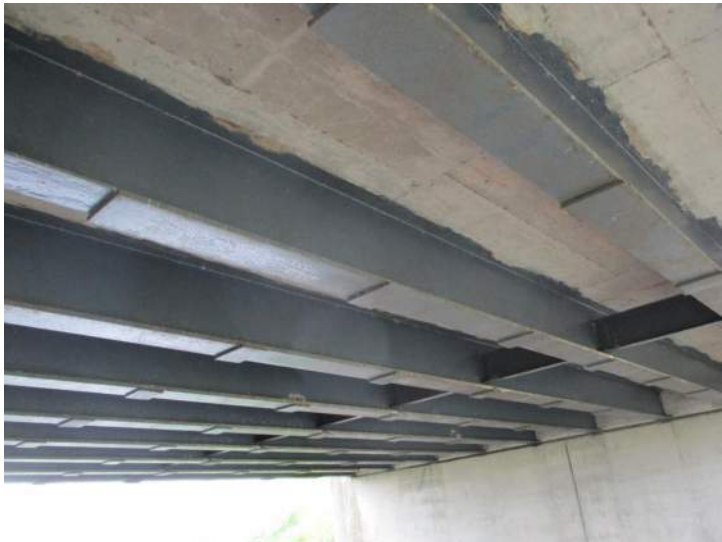
Document Name: 87.JPG  
Category: Superstructure  
Span Number:  
Comments: Beams

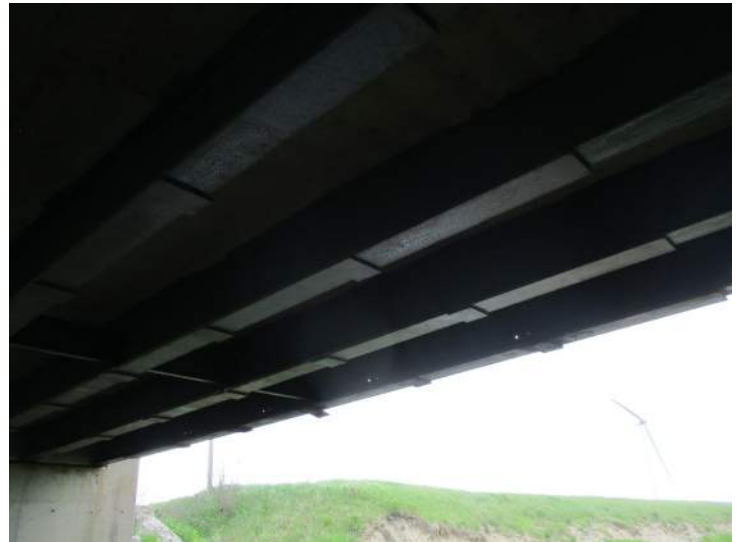
Document Name: 89.JPG  
Category: Superstructure  
Span Number:  
Comments: Beam 1s, drilled holes

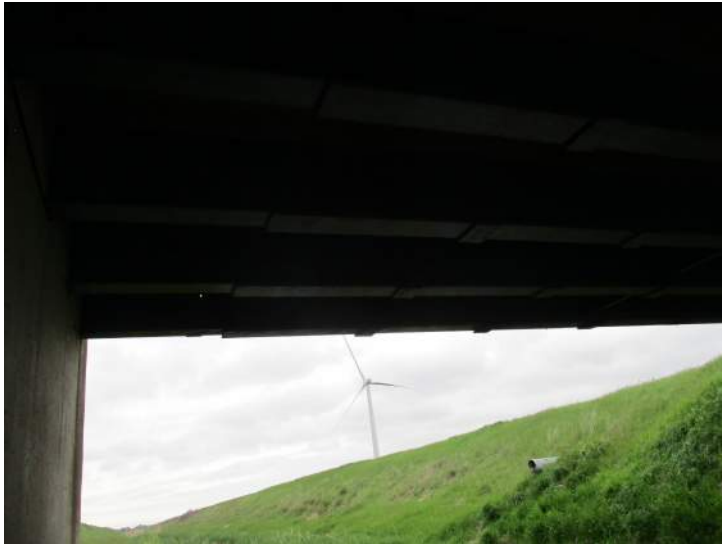
Document Name: 90.JPG  
Category: Superstructure  
Span Number:  
Comments: Beam 10s, drilled holes

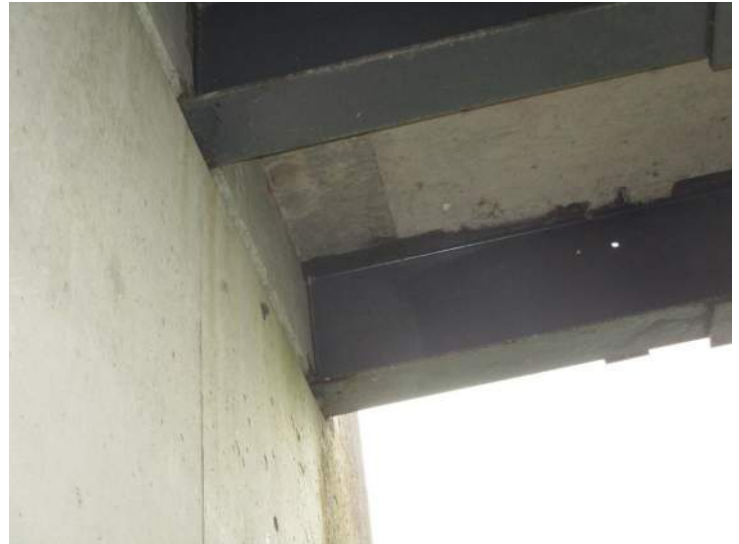
10 steel I-beams with square end cover plates applied in 4' +/- sections in 1990. Steel channel diaphragms at midspan. Splice Plates for cover plates loose and rusty at beam 1s and 10s. Several tack welds at cover plate splices. Beam 1S, 6S and 10S have pairs of drilled holes through webs, (6) pairs per beam. Painted over pitting in some locations is evident. Rust on bottom flange of beam 10s at west abutment. Top flanges of fascia beams have scaled rust on the outside. (05/19)

Document Name: 93.JPG  
Category: Superstructure  
Span Number:  
Comments: Beam 10s, west abutment, scale

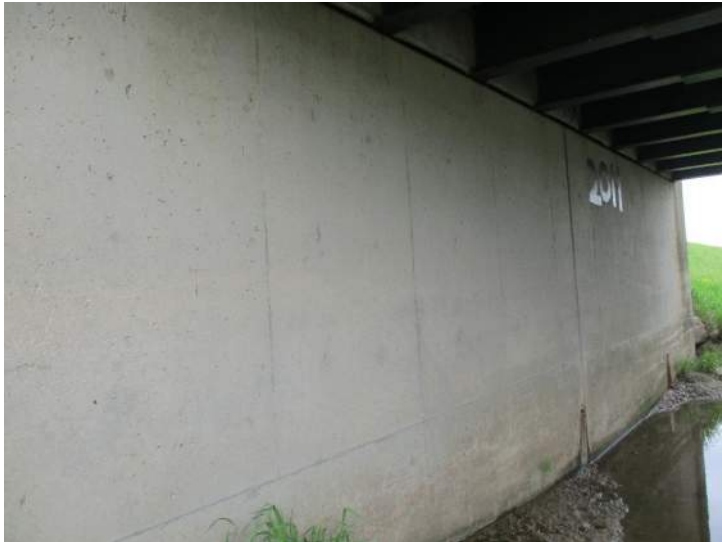
Document Name: 85.JPG  
Category: Substructure  
Span Number:  
Comments: West abutment

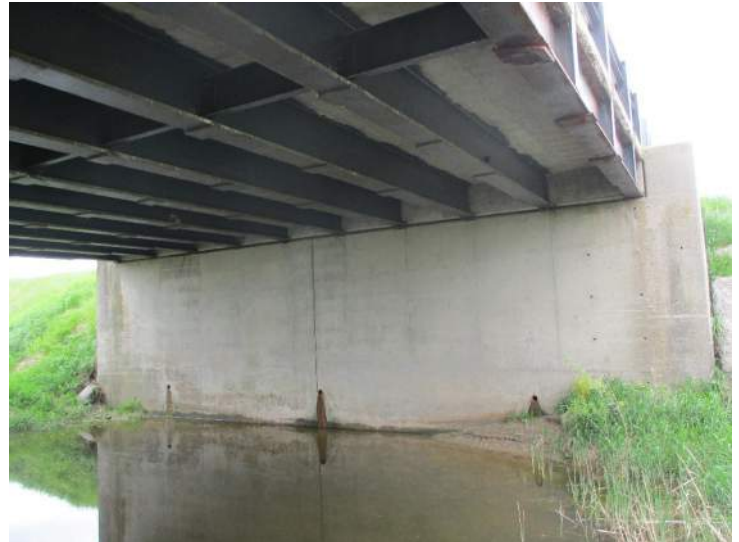
Document Name: 86.JPG  
Category: Substructure  
Span Number:  
Comments: East abutment
