**TUSCOLA COUNTY ROAD COMMISSION  
REQUEST FOR PROPOSAL  
PROFESSIONAL ENGINEERING AND BRIDGE DESIGN SERVICES**

**Structure No 10552, Belsay Road over Thetford-Arbela Drain, T10N R07E**

STR 10552		BRIDGE SAFETY INSPECTION REPORT		
<b>Facility</b>	<b>Latitude / Longitude</b>	<b>MDOT Structure ID</b>	<b>Structure Condition</b>	
BELSAY ROAD	43.255 / -83.602	79303H00054B010	Serious Condition(3)	
<b>Feature</b>	<b>Length / Width / Spans</b>	<b>Owner</b>		
THETFORD-ARBELA DRAIN	21 / 27.6 / 1	County: Tuscola(79)		
<b>Location</b>	<b>Built / Recon. / Paint / Ovly.</b>	<b>TSC</b>	<b>Operational Status</b>	
SEC 23-24 ARBELA TWP	1965 / / / 1983	Huron(28)	P Posted for load(222943)	
<b>Region / County</b>	<b>Material / Design</b>	<b>Last NBI Inspection</b>	<b>Scour Evaluation</b>	
Bay(4) / Tuscola(79)	3 Steel / 02 Multi Str Non Comp	06/13/2021 / GEUO	U Unknown Scour

SUPPORTING IMAGES

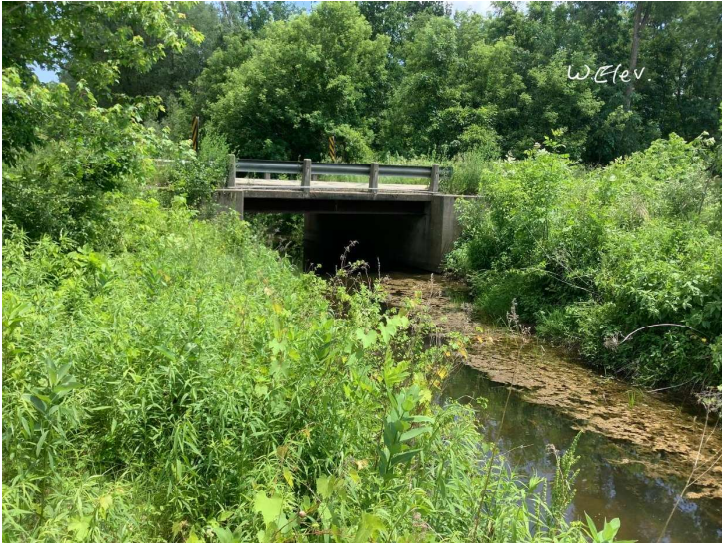
Document Name: IMG\_3372.JPEG  
 Category: Elevation  
 Span Number:  
 Comments: West elevation

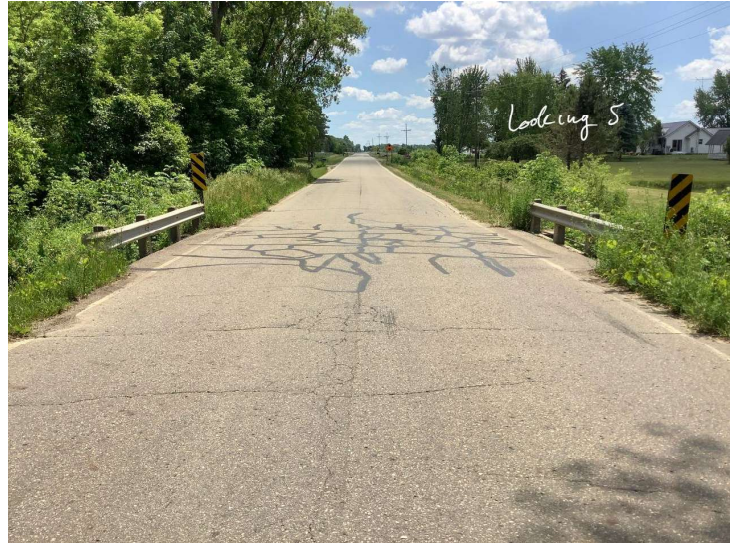
Document Name: IMG\_3374.JPEG  
 Category: Approach  
 Span Number:  
 Comments: Looking south

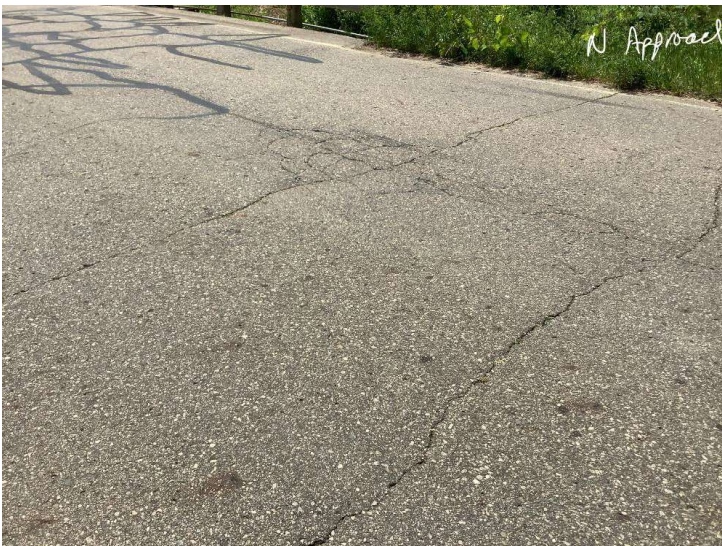
Document Name: IMG\_3378.JPEG  
 Category: Approach  
 Span Number:  
 Comments: North approach

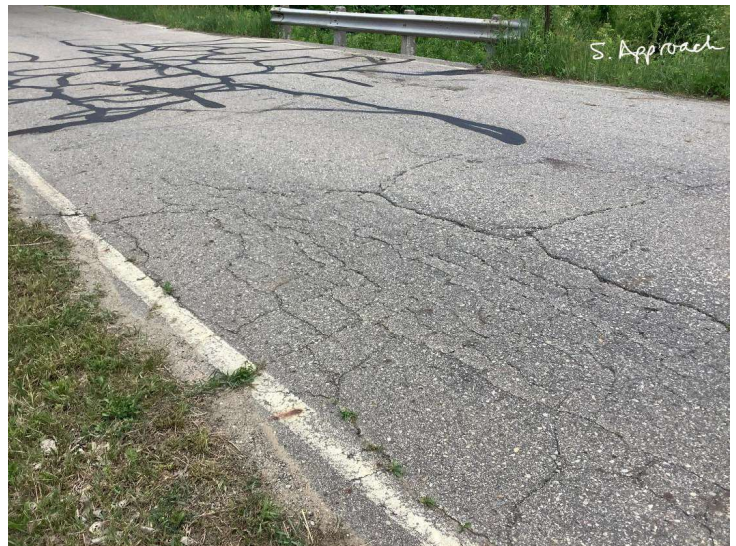
Document Name: IMG\_3389.JPEG  
 Category: Approach  
 Span Number:  
 Comments: South approach

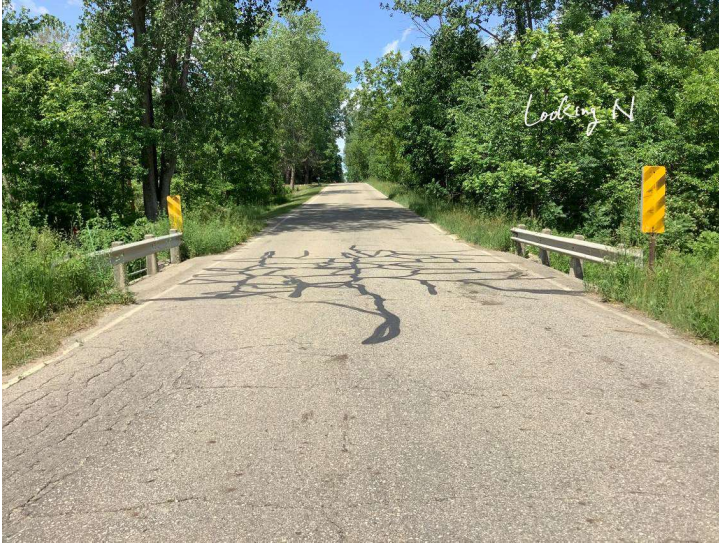
Document Name: IMG\_3426.JPEG  
 Category: Approach  
 Span Number:  
 Comments: Looking north

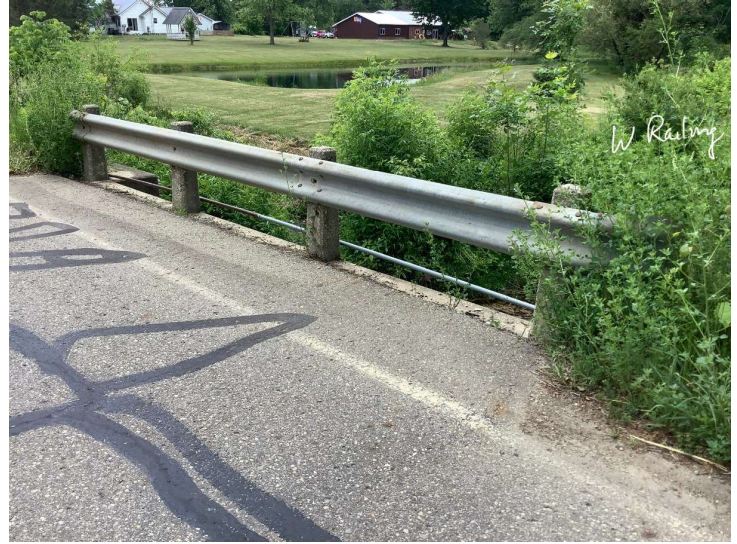
Document Name: IMG\_3381.JPEG  
 Category: Railing  
 Span Number:  
 Comments: West railing

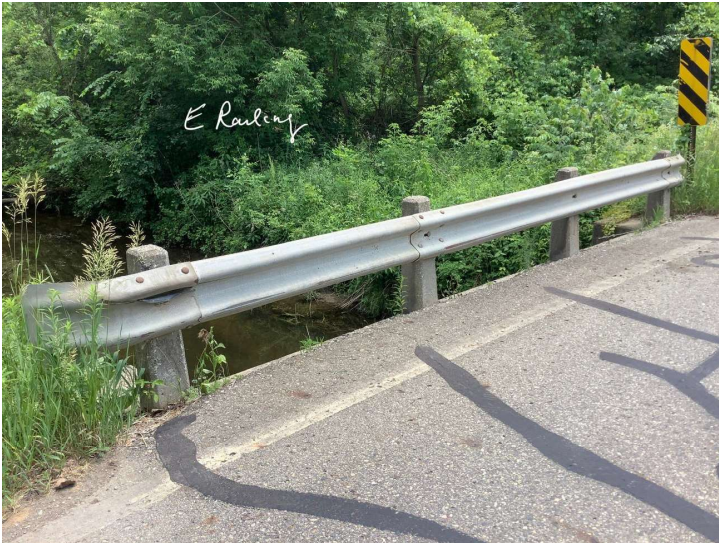
Document Name: IMG\_3383.JPEG  
 Category: Railing  
 Span Number:  
 Comments: East railing

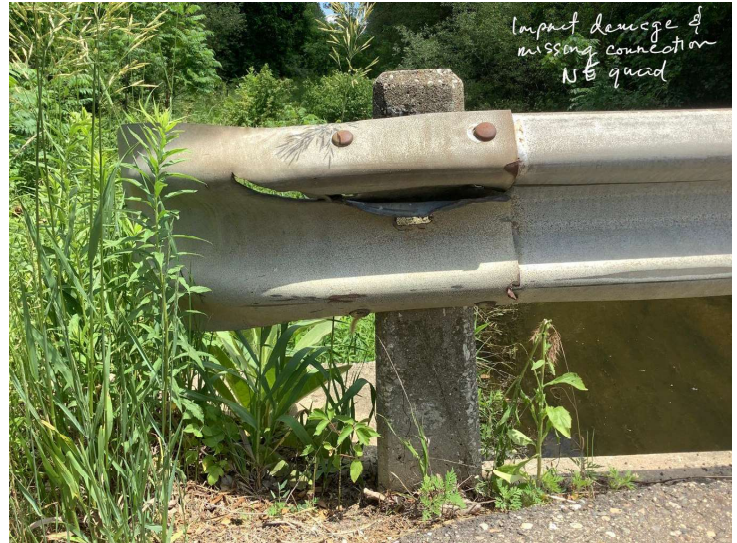
Document Name: IMG\_3384.JPEG  
 Category: Railing  
 Span Number:  
 Comments: Impact damage and missing connection, NE quad

Recommendation Type	Priority	Description
Scour Repair	M	Add riprap along abutments.
Approach Repair	H	Seal cracks in HMA
Brush Cut	M	Brush cut
Railing Repair	H	Update guardrail on structure and approaches.
Deck Patching	H	Seal cracks in HMA
Super Repair	H	Repair fascia beam ends.

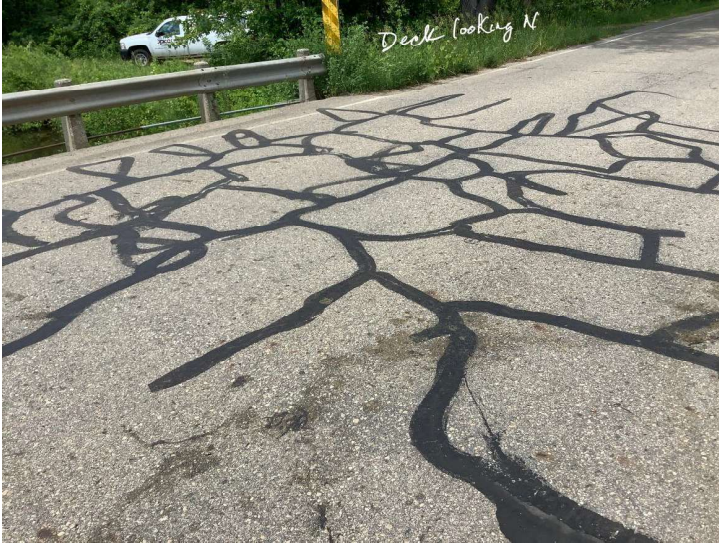
Document Name: IMG\_3387.JPEG  
 Category: Deck  
 Span Number:  
 Comments: Deck, looking north

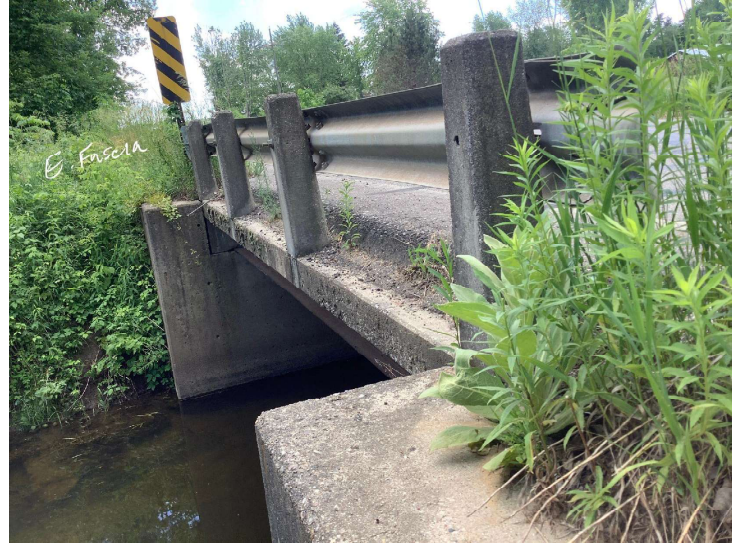
Document Name: IMG\_3393.JPEG  
 Category: Superstructure  
 Span Number:  
 Comments: East fascia

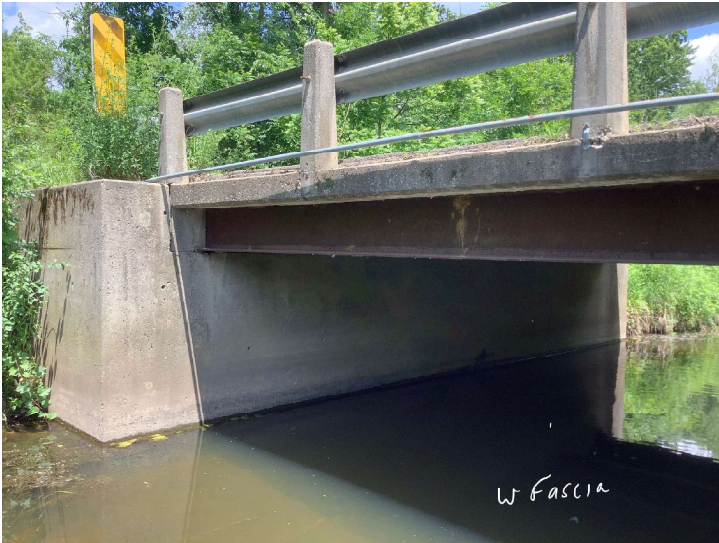
Document Name: IMG\_3395.JPEG  
 Category: Superstructure  
 Span Number:  
 Comments: West fascia

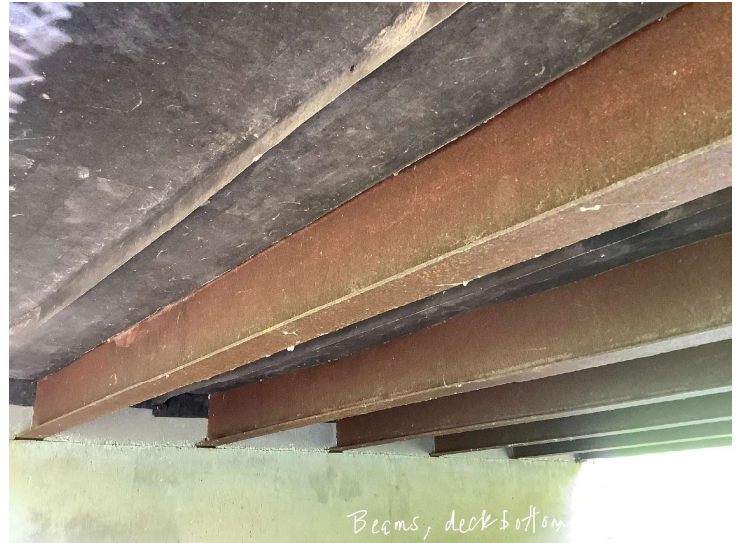
Document Name: IMG\_3398.JPEG  
 Category: Superstructure  
 Span Number:  
 Comments: Beams, deck bottom

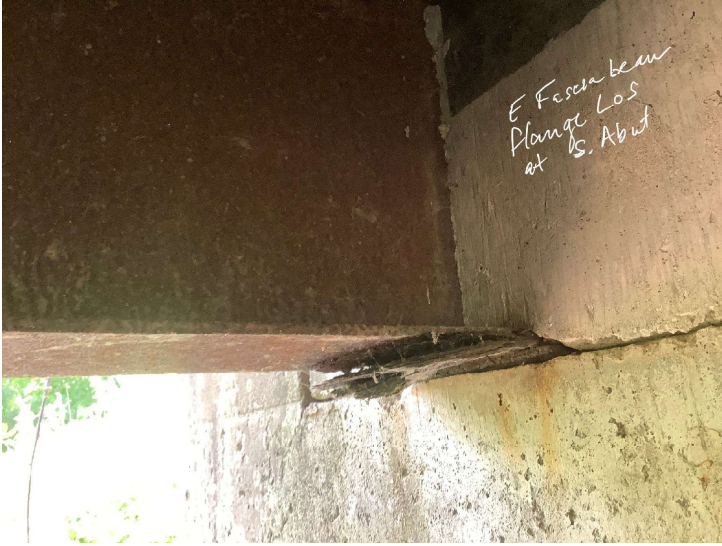
Document Name: IMG\_3401.JPEG  
 Category: Superstructure  
 Span Number:  
 Comments: East fascia beam, flange LOS at south abutment

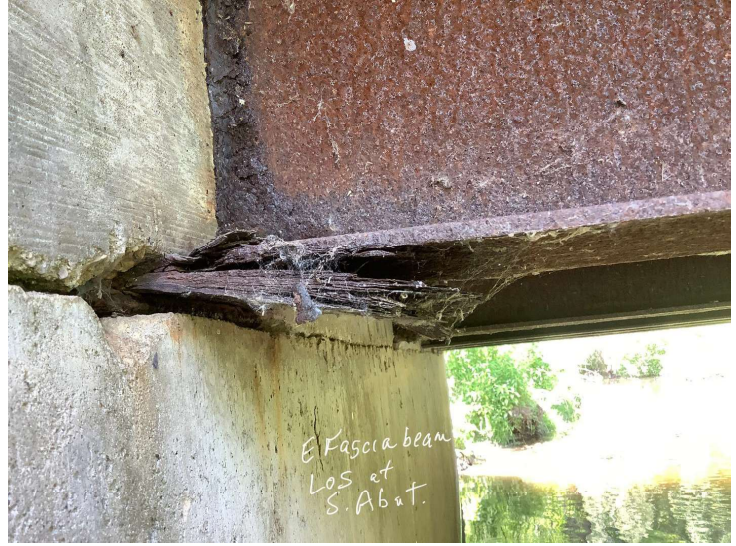
Document Name: IMG\_3404.JPEG  
 Category: Superstructure  
 Span Number:  
 Comments: East fascia beam, LOS at south abutment

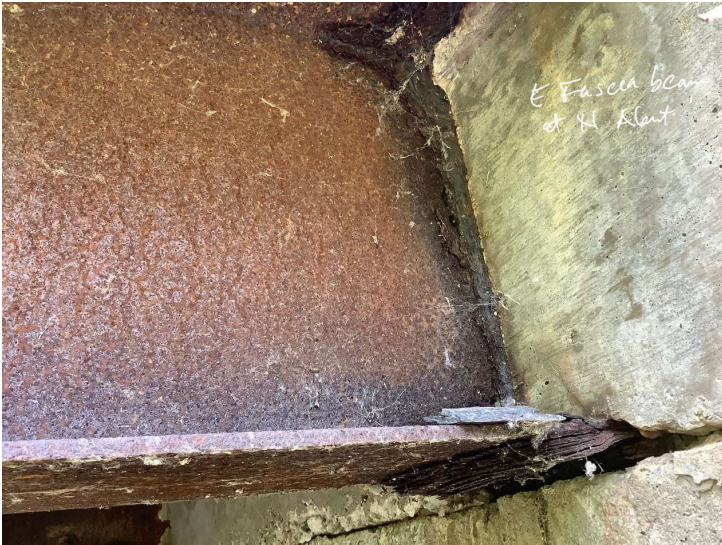
Document Name: IMG\_3418.JPEG  
 Category: Superstructure  
 Span Number:  
 Comments: East fascia beam at north abutment

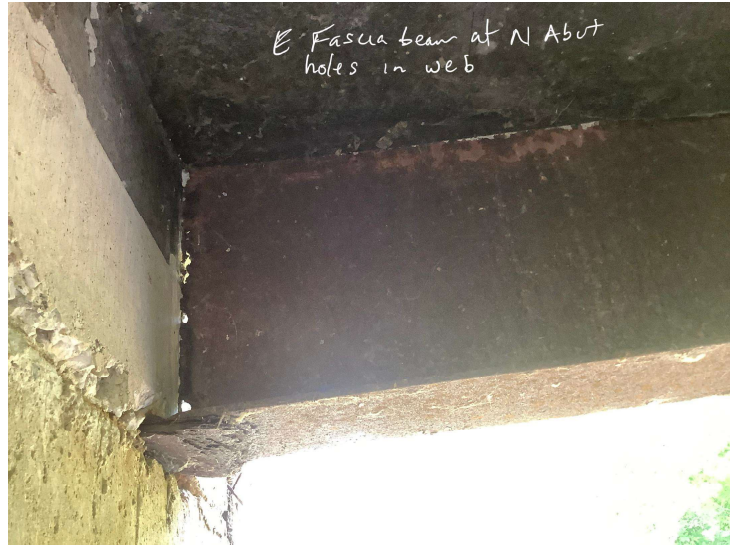
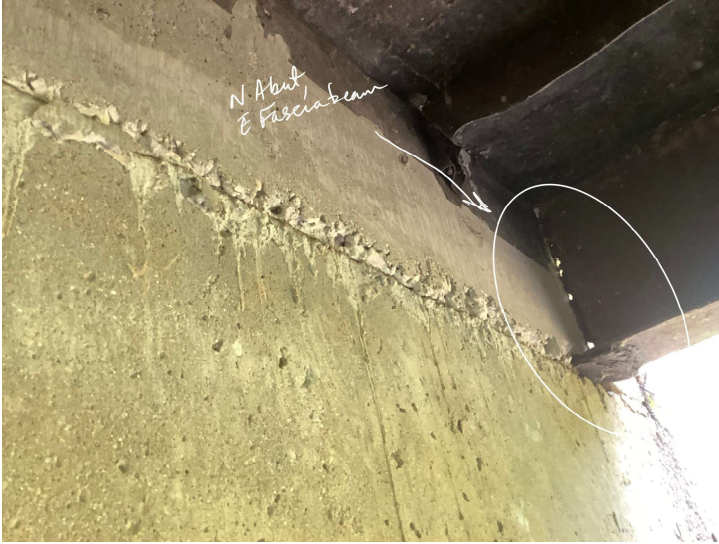
<b>9. Stringer (SIA-59)</b>	5	5	3	7 steel I-beams. Uniform corrosion throughout with moderate to sever corrosion at ends of fascia beams near backwall. Beam 7w (East Fascia Beam) at north end has 5 small holes in web and the bottom flange is nearly rusted away. Bottom flange has heavy steel flacking at both bearings. (06/21) There are 7 steel I-beams. Uniform rust throughout. Scale on ends of fascias only. Beam 7w at north end has 2 small holes in the web at the back wall interface with heavy pitting most of the height. (06/19) There are 7 steel I-beams. Uniform rust throughout. Scale on ends of fascias only. Beam 7w at north end has 2 small holes in the web at the back wall interface with heavy pitting most of the height. (06/17)
<b>10. Paint (SIA-59A)</b>	N	N	N	No paint on beams (06/21) No paint on beams (06/19) No paint on beams (06/17)
<b>11. Section Loss</b>	0	0	0	Scale on ends of fascia beams. Holes in web of beam 7w at north end and near 100% loss of bottom flange. (06/21) Scale on ends of fascia beams. Holes in beam 7w at north end. (06/19) Scale on ends of fascia beams. Holes in beam 7w at north end. (06/17)

Document Name: IMG\_3421.JPEG  
 Category: Superstructure  
 Span Number:  
 Comments: East fascia beam at north abutment, holes in web

Document Name: IMG\_3422.JPEG  
 Category: Superstructure  
 Span Number:  
 Comments: East fascia beam at north abutment, holes in web

East Fascia: 49% of total web thickness deteriorated, 90% of total bottom flange deteriorated

East Fascia Beam has severe section loss near N. Abutment Backwall. Based on the 6/13/21 field inspection, it is recommended the shoulder be closed to keep traffic from placing loads on the fascia beam. (Rich Kathrens, P.E. 06/17/2021)

<b>Request For</b> Super Repair	<b>Contact/User</b>	<b>Agency/Company Name</b>	<b>Estimated Quantity</b>	<b>Unit</b>
<b>Activity</b>	<b>Material</b>	<b>Other Material</b>	<b>Actual Quantity</b>	<b>Unit</b>
<b>Personnel Hours</b>	<b>Equipment</b>			<b>Complete Date</b>
<b>Comments</b> Repair fascia beam ends. (Rich Kathrens, P.E. 06/17/2021)

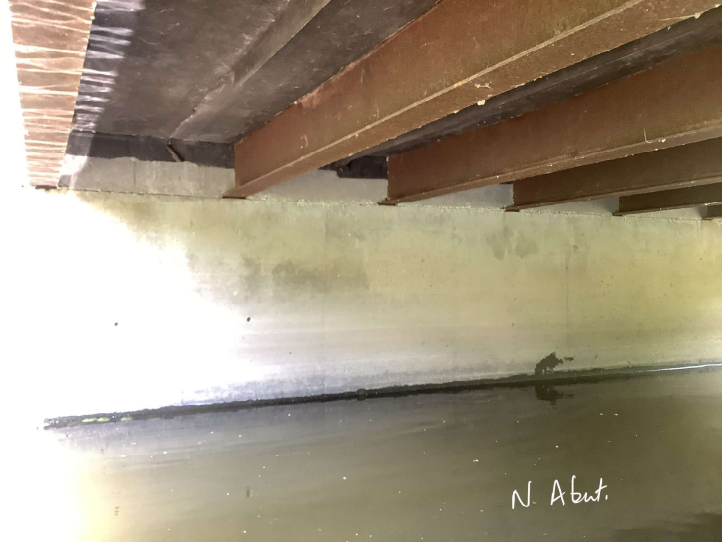
Document Name: IMG\_3397.JPEG  
 Category: Substructure  
 Span Number:  
 Comments: North abutment

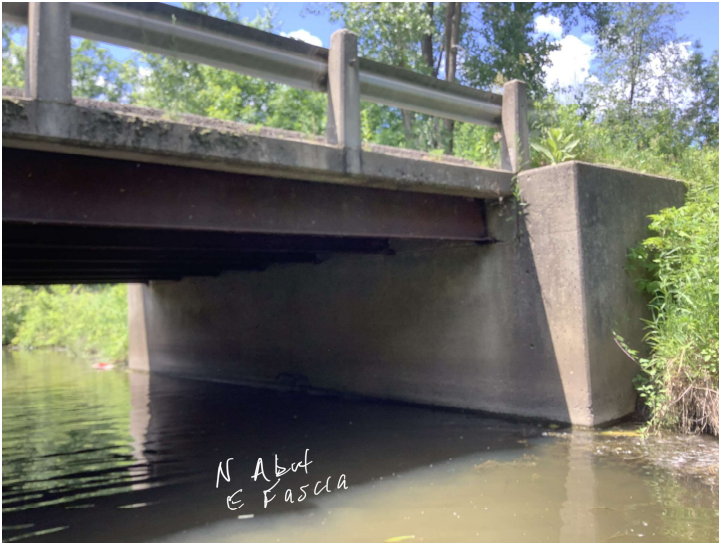
Document Name: IMG\_3406.JPEG  
 Category: Substructure  
 Span Number:  
 Comments: North abutment, east fascia

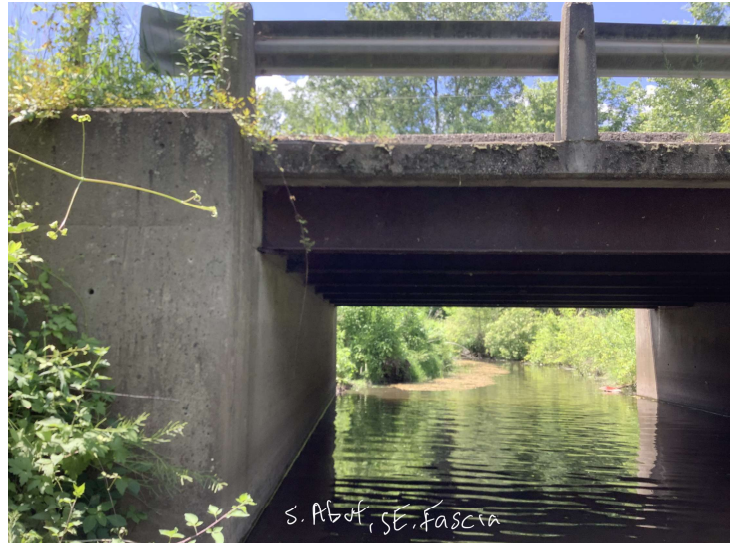
Document Name: IMG\_3407.JPEG  
 Category: Substructure  
 Span Number:  
 Comments: South abutment, east fascia

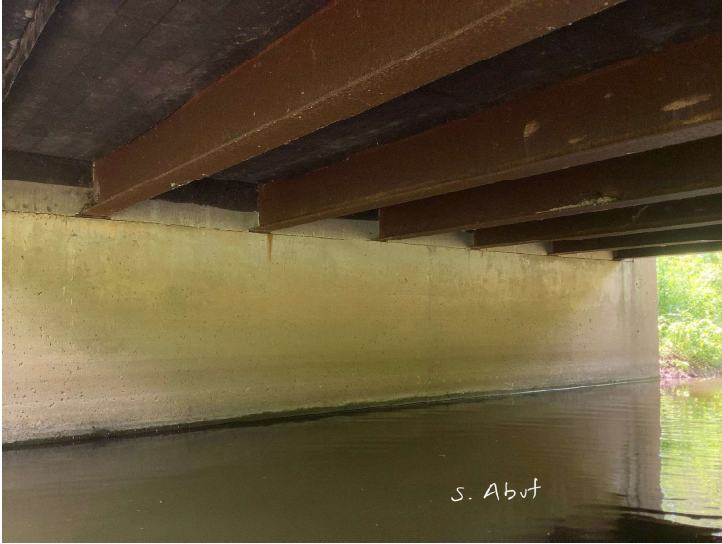
Document Name: IMG\_3420.JPEG  
 Category: Substructure  
 Span Number:  
 Comments: South abutment

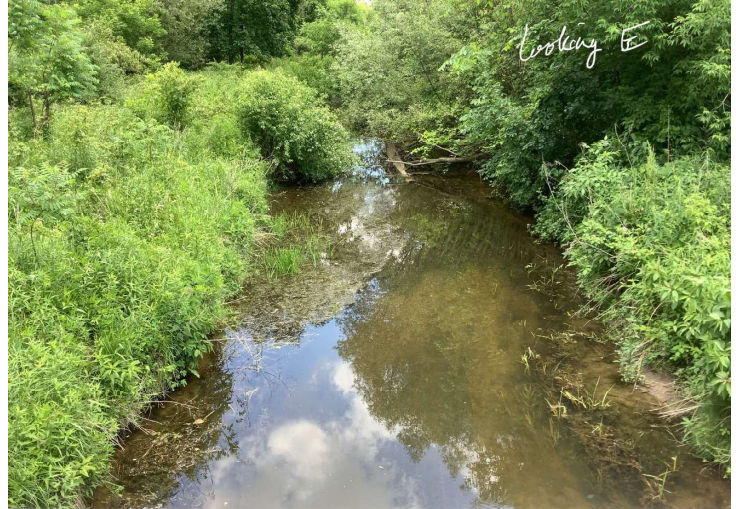
Document Name: IMG\_3379.JPEG  
 Category: Channel  
 Span Number:  
 Comments: Looking east

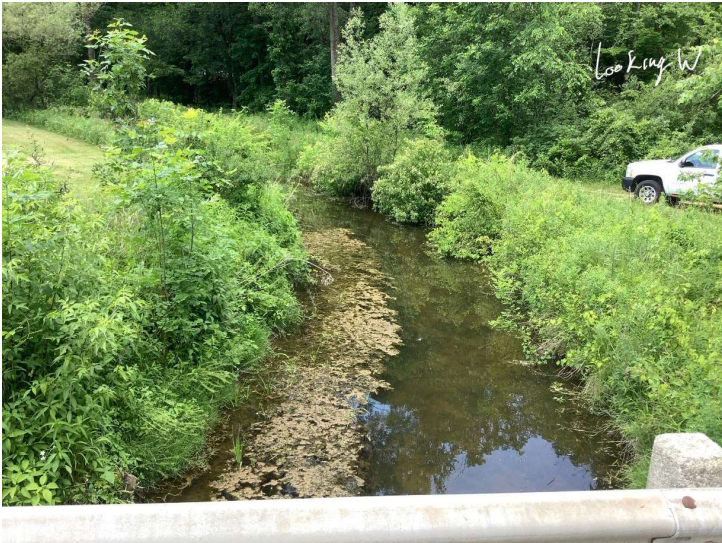
Document Name: IMG\_3380.JPEG  
 Category: Channel  
 Span Number:  
 Comments: Looking west

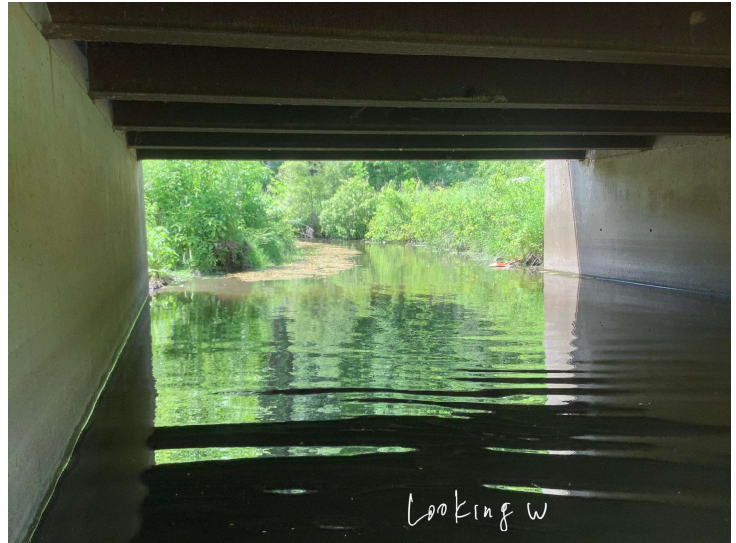
Document Name: IMG\_3405.JPEG  
 Category: Channel  
 Span Number:  
 Comments: Looking west

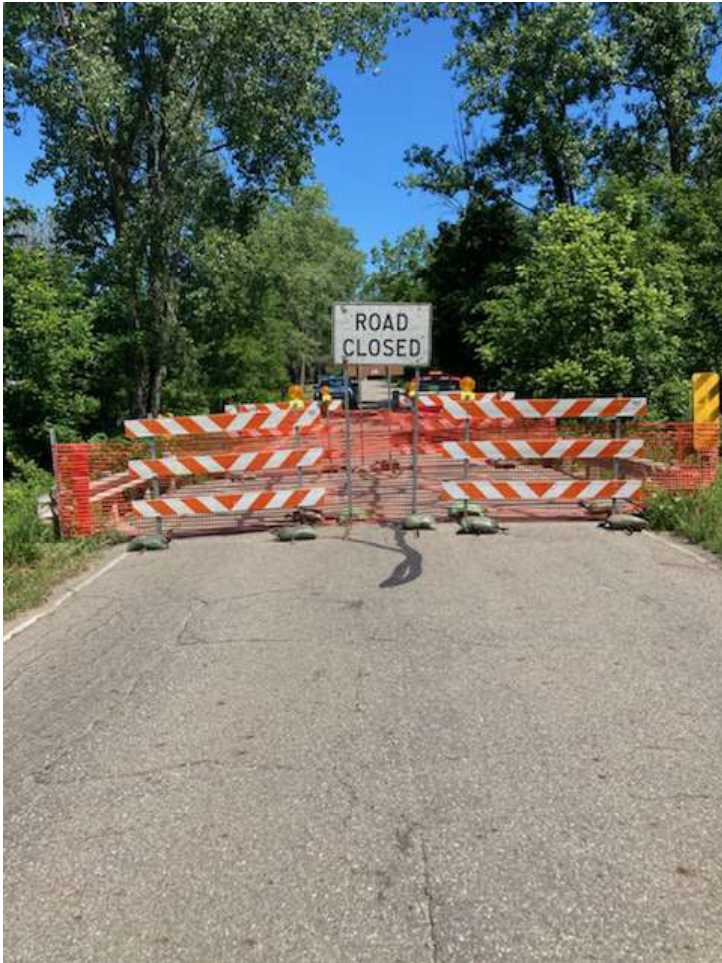
Document Name: Closed Looking N.jpg  
 Category: Posting  
 Span Number:  
 Comments: Looking North

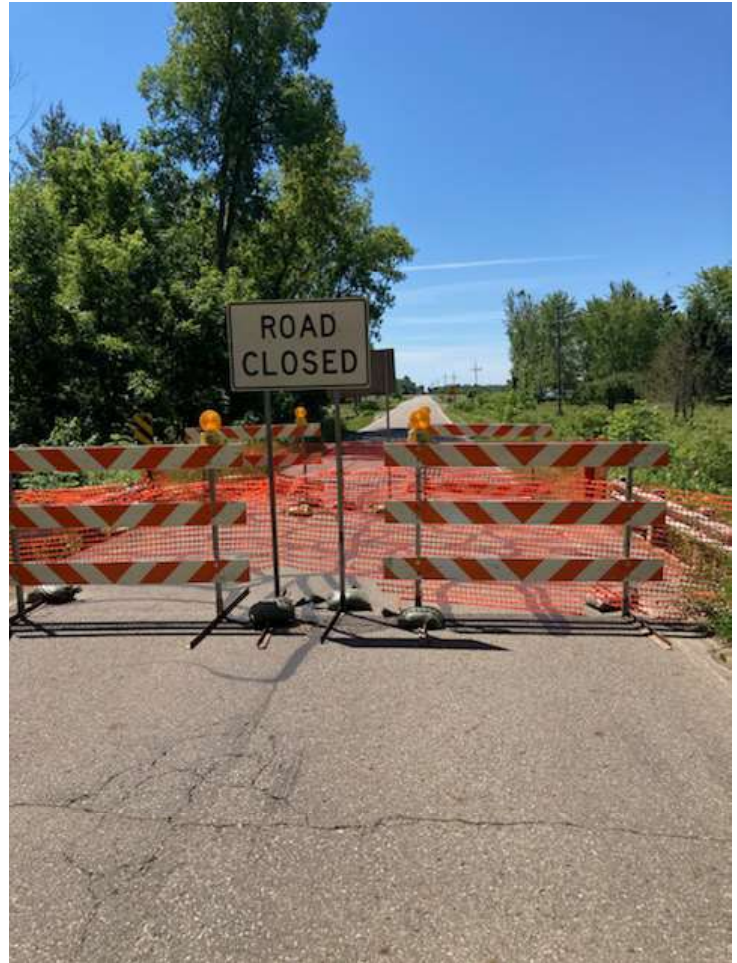
Document Name: Closed Looking S.jpg  
 Category: Posting  
 Span Number:  
 Comments: Looking South

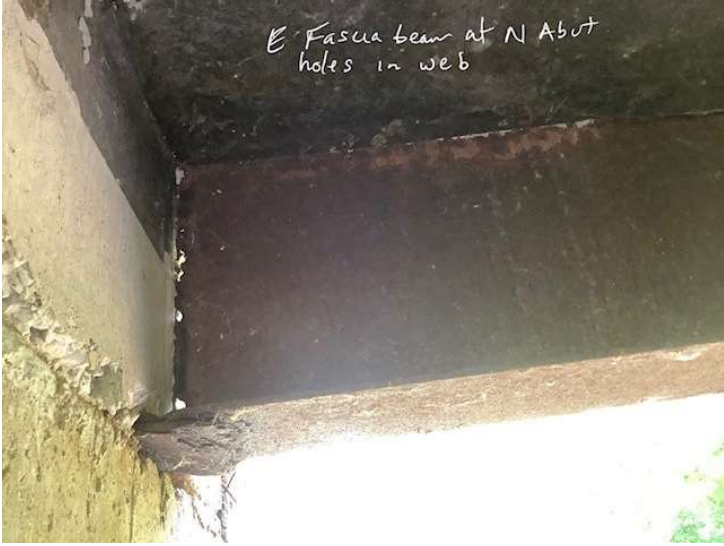
Document Name: E Fascia at N Abut (1).jpg  
 Category: Superstructure  
 Span Number:  
 Comments: East Fascia Beam, North End, Holes in Web

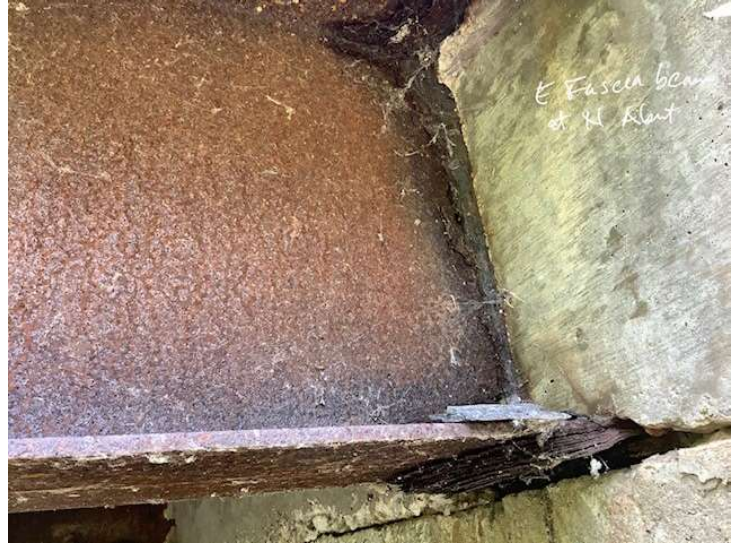
Document Name: E Fascia at N Abut (2).jpg  
 Category: Superstructure  
 Span Number: 1  
 Comments: East Fascia Beam, North End
