Snover Road Bridge #12662 over Beach Drain
Bridge Design
Letting Date – March 12th, 2026 8:45am

Snover Road Bridge #12662 over the Beach Drain

Structure No. 12662, Snover Road over Beach Drain, is nearing the end of its life and needs to be replaced. The Snover Road Bridge over the Beach Drain is a single span structure totaling 25.5 feet in length. This structure carries 2 lanes of traffic and has an inside width of 28 feet. The bridge superstructure consists of thirteen steel I-beams with chip sealed HMA wearing surface. Corrugated steel deck panels left in place on deck bottom with light corrosion. Both reference line joints are paved over with faint reflective cracking. The railing along each side of structure consists of W-beam guardrail mounted to steel posts anchored to the fascia beams. Fascia beams are spliced and longer than the interior beams and have been repainted. Beams 5S-9S have additional sections of welded bottom flange repair plates. Beams 6S-8S, 12S and 13S have plate web repairs. Beams 5S and 9S have bolted repairs of holes in the web near the west backwall. The substructures consist of concrete cantilever abutments with scaling along the waterline. The east

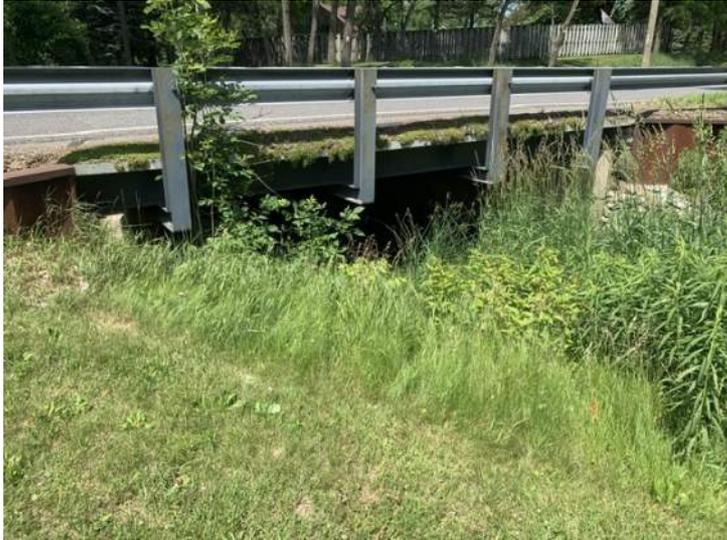
Document Name: IMG_0042.jpeg
 Category: Elevation
 Span Number:
 Comments: South elevation

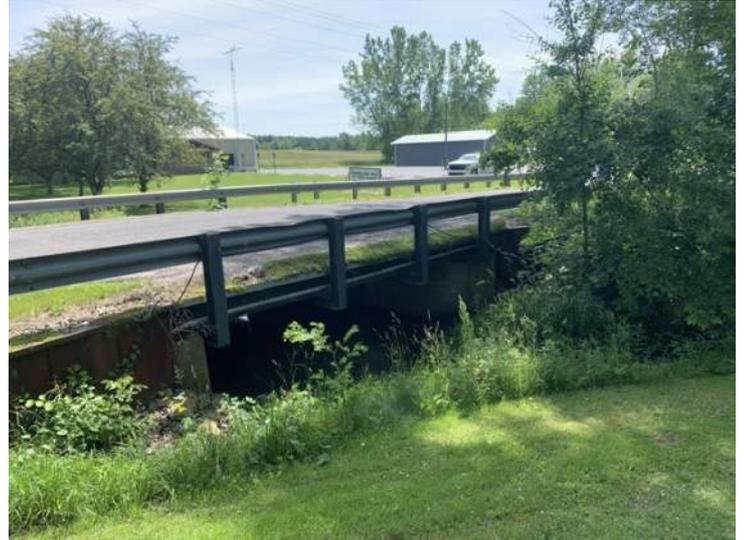
Document Name: IMG_0048.jpeg
 Category: Elevation
 Span Number:
 Comments: North elevation

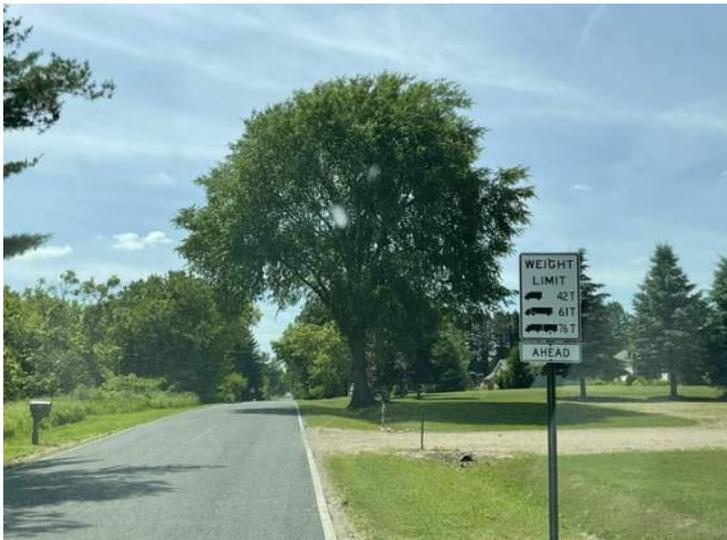
Document Name: IMG_6935.jpeg
 Category: Posting
 Span Number:
 Comments: Advanced posting sign east of structure

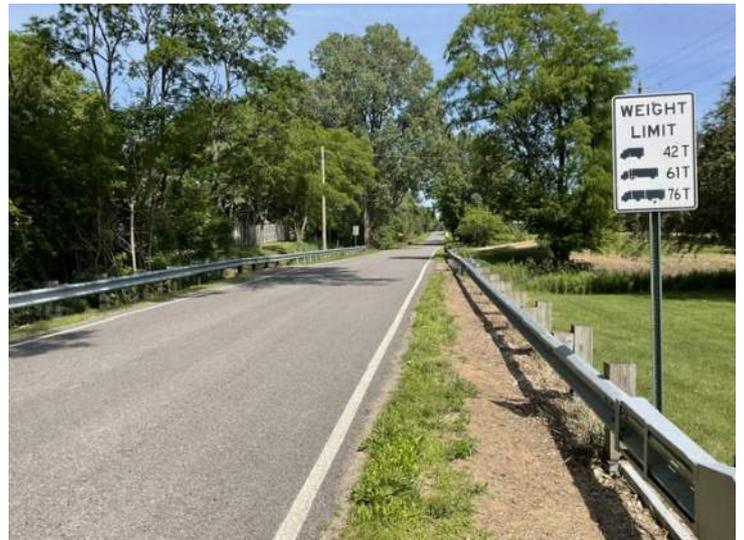
Document Name: IMG_6936.jpeg
 Category: Posting
 Span Number:
 Comments: Posting sign at west end of structure

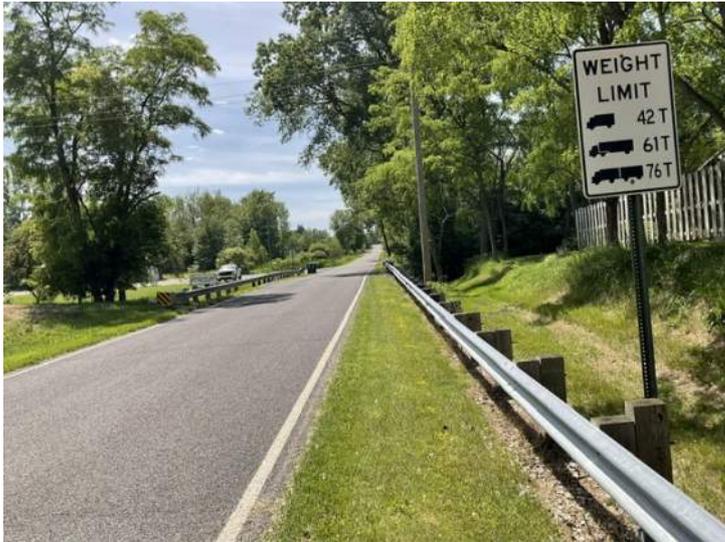
Document Name: IMG_6940.jpeg
 Category: Posting
 Span Number:
 Comments: Posting sign at east end of structure

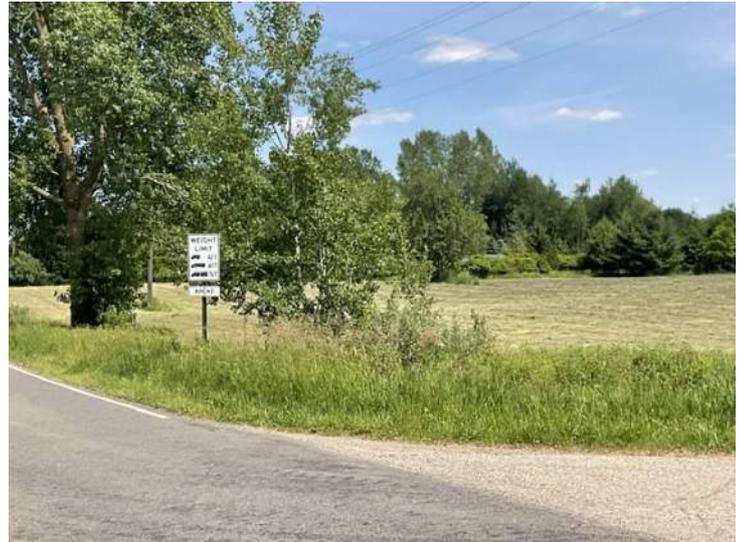
Document Name: IMG_6952.jpeg
 Category: Posting
 Span Number:
 Comments: Advanced posting west of structure

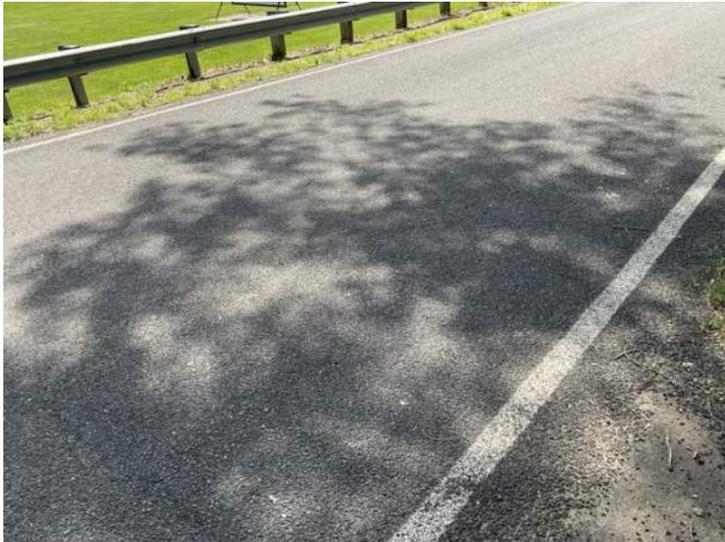
Document Name: IMG_6942.jpeg
 Category: Approach
 Span Number:
 Comments: West approach

18. Approach Pavement	7	7	7	Chip sealed HMA approaches. No deficiencies noted. (06/24) Chip sealed HMA approaches. No deficiencies noted. (06/23) HMA approach pavement with sealed transverse cracks. Partially sealed with the deck. Newer HMA wedge along east end of structure. (06/22)

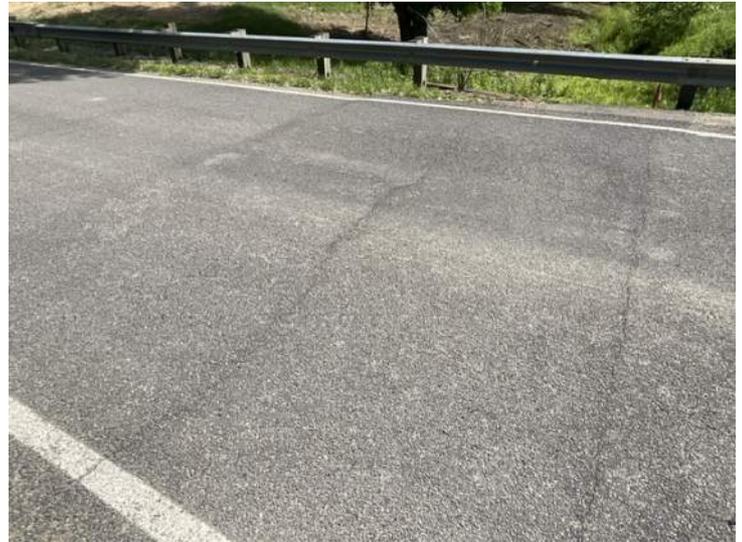
Document Name: IMG_6943.jpeg
 Category: Approach
 Span Number:
 Comments: East approach

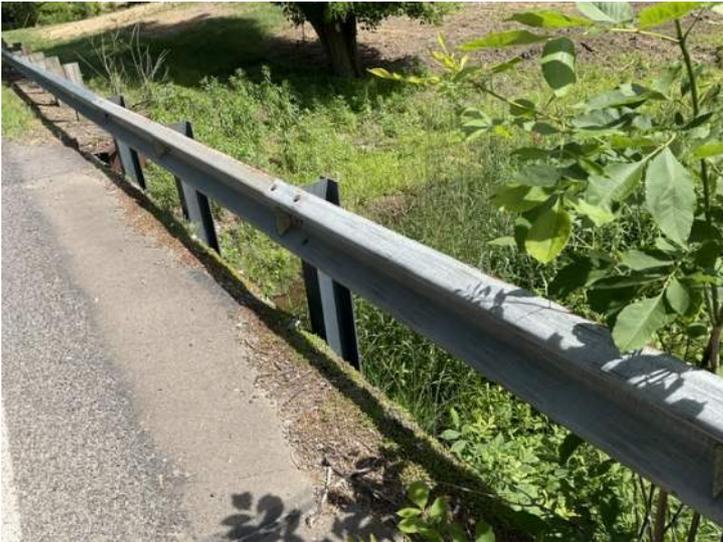
Document Name: IMG_6938.jpeg
 Category: Railing
 Span Number:
 Comments: Railing, typical

4. Railings	6	6	6	W-Beam guardrail mounted on steel I-posts that are welded to steel I-struts and connected to outer two fascia beams. No offset blocks. Minor impact damage to top of north rail near midspan. (06/24) W-Beam guardrail mounted on steel I-posts that are welded to steel I-struts and connected to outer two fascia beams. No offset blocks. Impact damage to top of north rail near midspan. (06/23) W-Beam guardrail mounted on steel I-posts that are welded to steel I-struts and connected to outer two fascia beams. No offset blocks. Impact damage to top of north rail. (06/22)

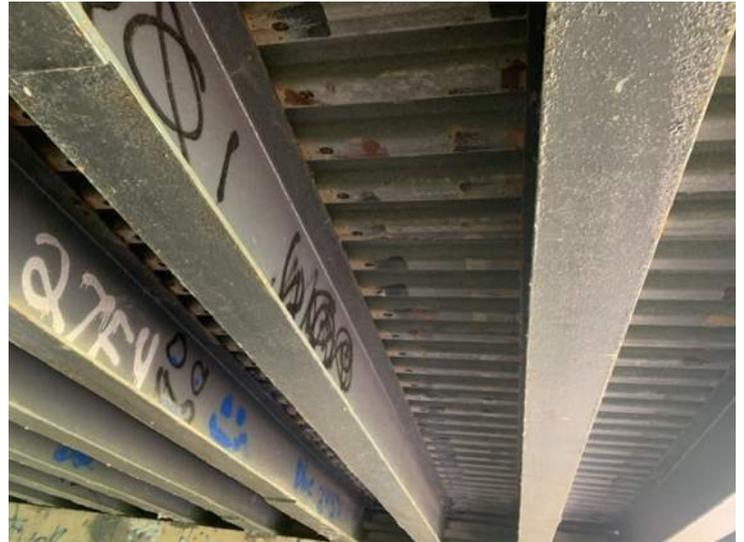
Document Name: IMG_0047.jpeg
 Category: Deck
 Span Number:
 Comments: Deck bottom surface, typical

5. Sidewalks or Curbs	N	N	N	(06/24) (06/23) (06/22)
6. Deck Bottom Surface (SIA-58B)	6	6	6	Corrugated steel deck panels with light corrosion at a few pan drain holes and seams. Corrosion is heavier near each abutment reference line. (06/24) Corrugated steel deck panels with light corrosion at a few pan drain holes and seams. Corrosion is heavier near each abutment reference line. (06/23) Corrugated steel deck panels with light corrosion at a few pan drain holes and seams. Corrosion is heavier near each abutment reference line. (06/22)

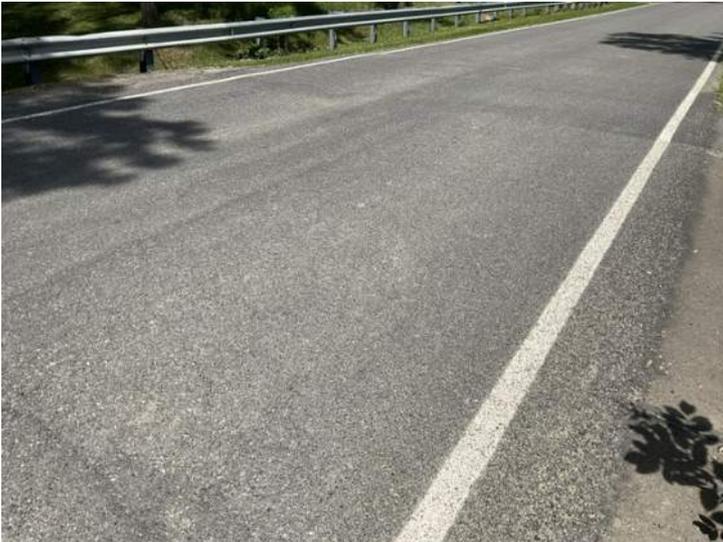
Document Name: IMG_6937.jpeg
 Category: Deck
 Span Number:
 Comments: Chip seal HMA surface above structure

06/22	06/23	06/24	
1. Surface (SIA-58A)	7	7	7	Chip sealed HMA surface along traveled lanes, original HMA surface visible along outer edges. No deficiencies noted. Minor vegetation growth along northern edge under railing. (06/24) Chip sealed HMA surface along traveled lanes, original HMA surface visible along outer edges. No deficiencies noted. (06/23) HMA surface. Full length longitudinal crack along centerline, partially sealed. Random transverse cracking in each lane up to 1/4" wide. (06/22)

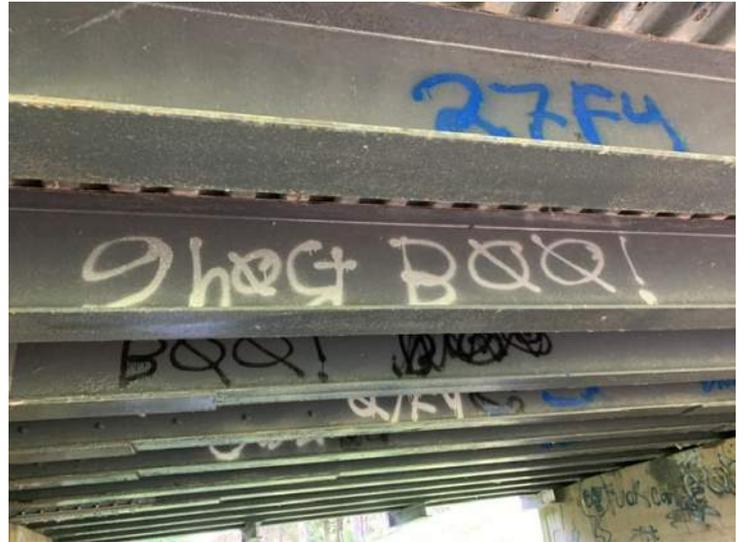
Document Name: IMG_0045.jpeg
 Category: Superstructure
 Span Number:
 Comments: Steel beams, typical

9. Stringer (SIA-59) 4 4 5 (13) Painted steel I-beams. The fascia beams are spliced and longer than the interior beams. Repainted. Beams 5s, 6s, 7s, 8s and 9s have additional sections of sporadic bottom flange repair plates varying in length (welded). Beams 6s, 7s, 8S, 12S and 13S also have plate web repairs. Beam 5S: bolted repair (1"x7" hole in lower portion of web approximately 1'-9" from west backwall.) Beam 9S: bolted repair (1"x9" hole in lower portion of web approximately 13" from west backwall). Pack rust on the bottom flange of beams 6S and 7S at the west abutment bearing location. Missed painting 1 beam end at the east abutment. (06/24)

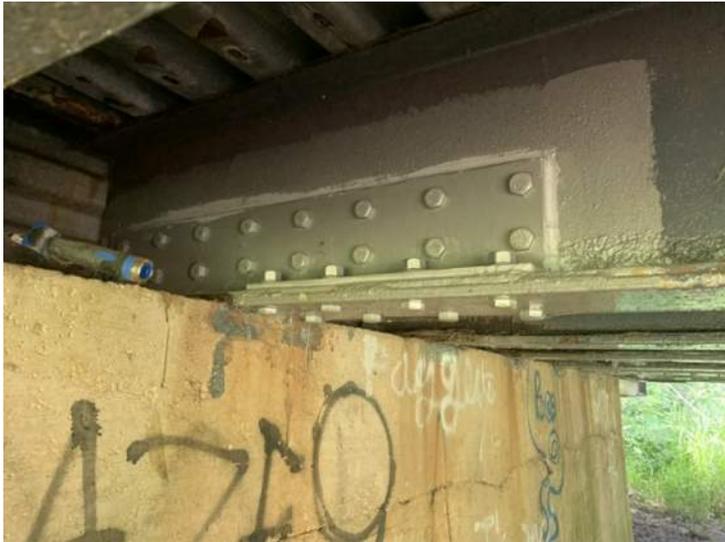
Document Name: IMG_0046.jpeg
 Category: Superstructure
 Span Number:
 Comments: Bolted steel plate repair at beam 9S

11. Section Loss	0	0	2	Bolted repairs at previous areas of section loss at (Beam 5S: 1"x7" hole in lower portion of web approximately 1'-9" from west backwall. Beam 9S: 1"x9" hole in lower portion of web approximately 13" from west backwall. Detailed beam measurements completed in 2022, notes uploaded in document tab.) (06/24) Beam 5S: 1"x7" hole in lower portion of web approximately 1'-9" from west backwall. Beam 9S: 1"x9" hole in lower portion of web approximately 13" from west backwall. Detailed beam measurements completed in 2022, notes uploaded in document tab. (06/23) There are 5 small holes in the web of beam 5s near the west end. There are 5 holes in the bottom of the web of beam 9s at the west end. (06/22)

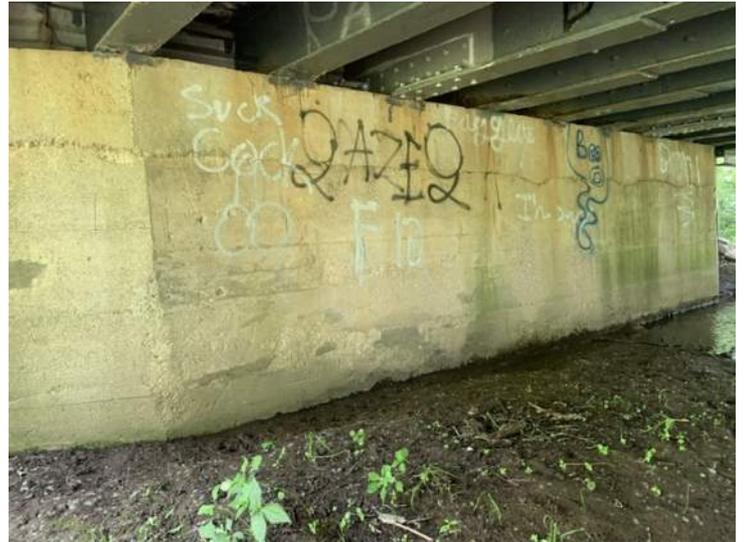
Document Name: IMG_0043.jpeg
 Category: Substructure
 Span Number:
 Comments: West abutment

06/22	06/23	06/24	
13. Abutments (SIA-60)	5	5	5	Concrete cantilever abutments. There is a 3/4"-1" open vertical and horizontal crack in the east abutment below beams 3S-5S with slight settlement. Scaling on both abutment walls near waterline. Offset corner patch in the west abutment in the southwest quadrant. The east footing face is buried in very soft sediment. (06/24) Concrete cantilever abutments. There is a 3/4"-1" open vertical and horizontal crack in the east abutment below beams 3S-5S with slight settlement. Scaling on both abutment walls near waterline. Offset corner patch in the west abutment in the southwest quadrant. The east footing face is buried in very soft sediment. (06/23) Concrete cantilever abutments. There is a 3/4"-1" open vertical and horizontal crack in the east abutment below beams 3S-5S with slight settlement. Scaling on both abutment walls near waterline. Offset corner patch in the west abutment in the southwest quadrant. The east footing face is buried in very soft sediment. (06/22)

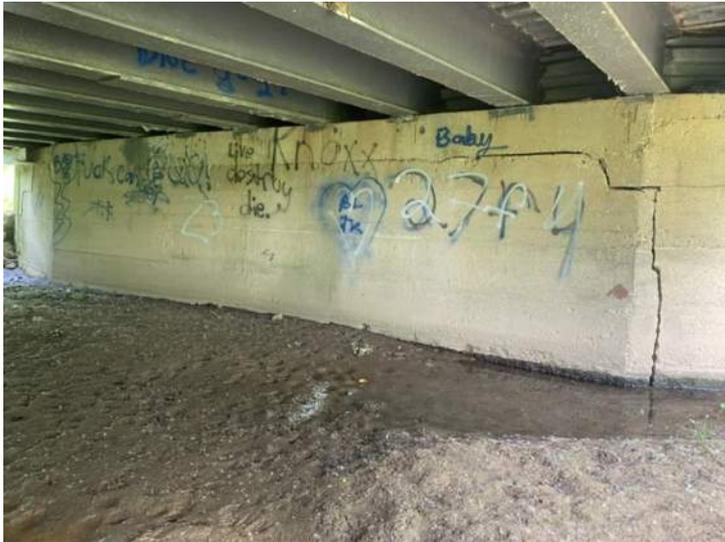
Document Name: IMG_0044.jpeg
 Category: Substructure
 Span Number:
 Comments: East abutment

Recommendation Type	Priority	Description
Scour Repair	H	Place riprap along east abutment. (21) (22) (23) (24)
Substr Repair	H	Monitor crack/settlement in East abutment (21) (22) (23) (24)

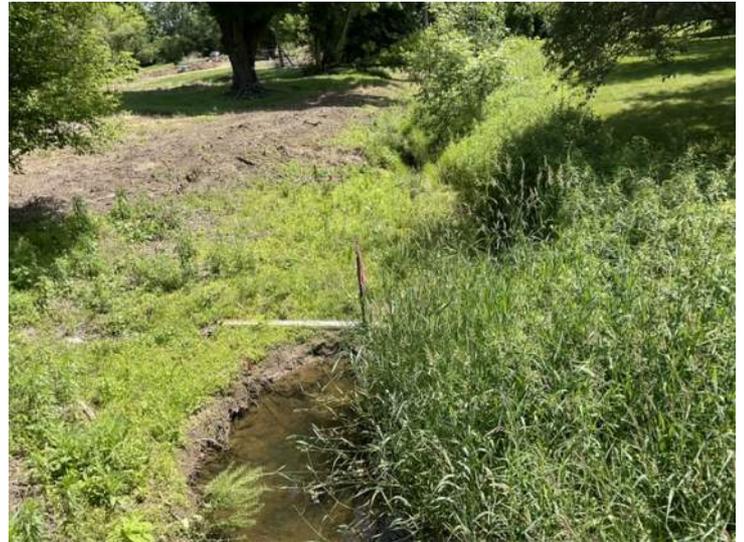
Document Name: IMG_6939.jpeg
 Category: Channel
 Span Number:
 Comments: Looking south off structure

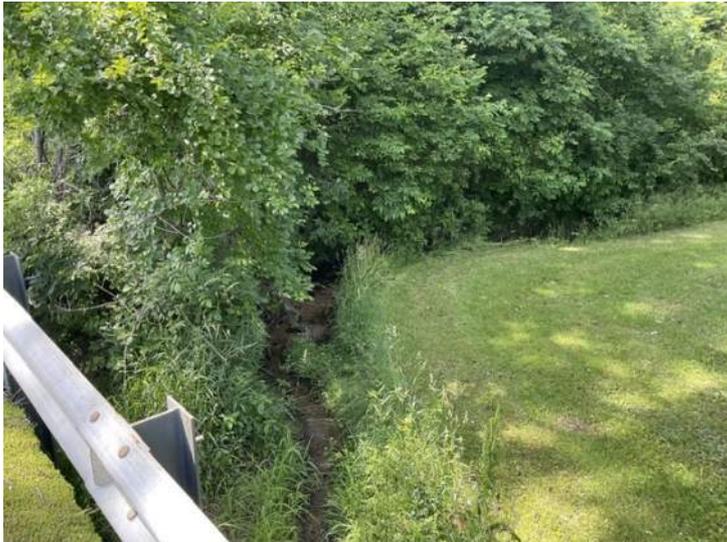
Document Name: IMG_6941.jpeg
 Category: Channel
 Span Number:
 Comments: Looking north off structure

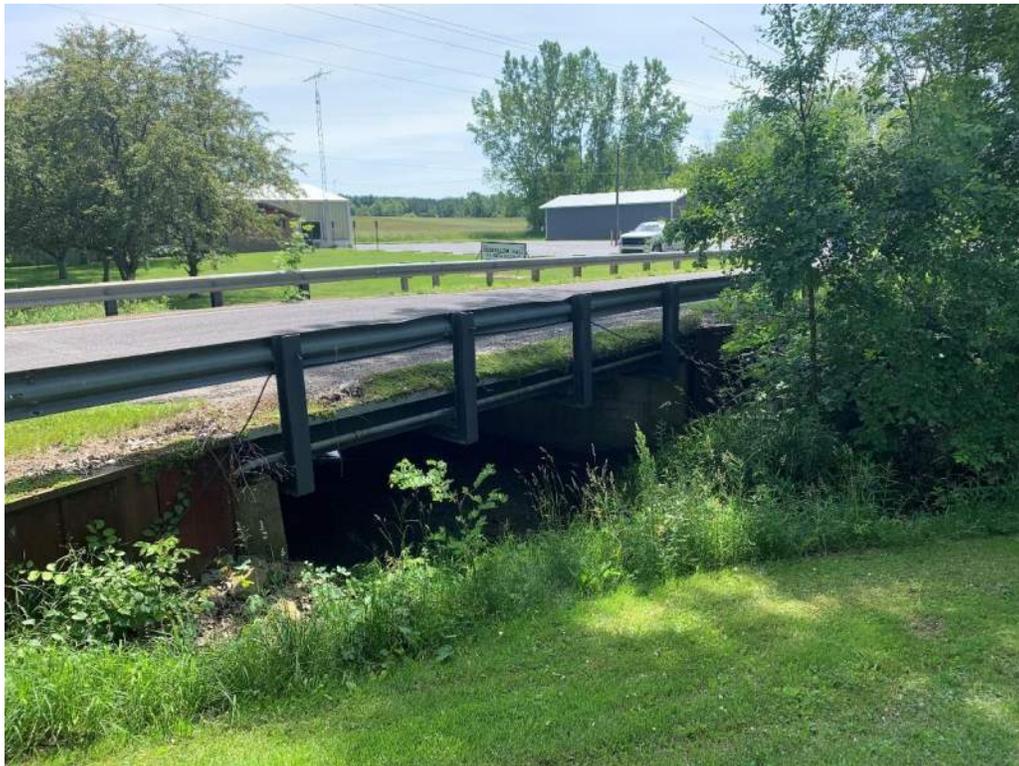
Fascia of Snover Road Bridge

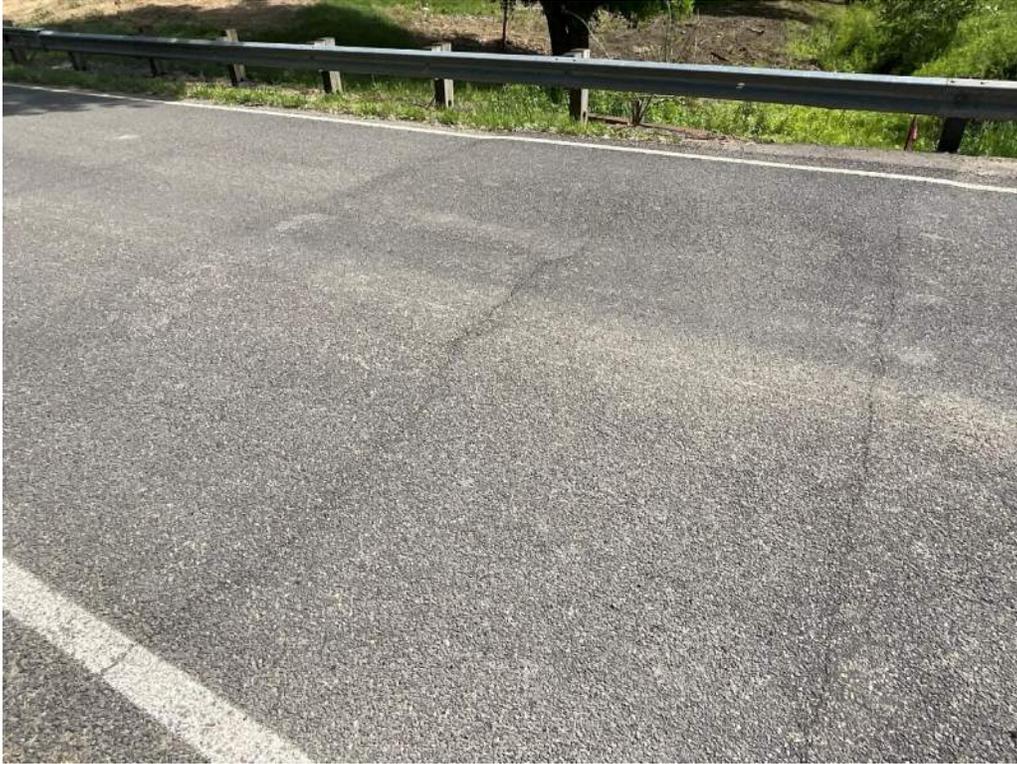
HMA pavement over the Snover Road Bridge

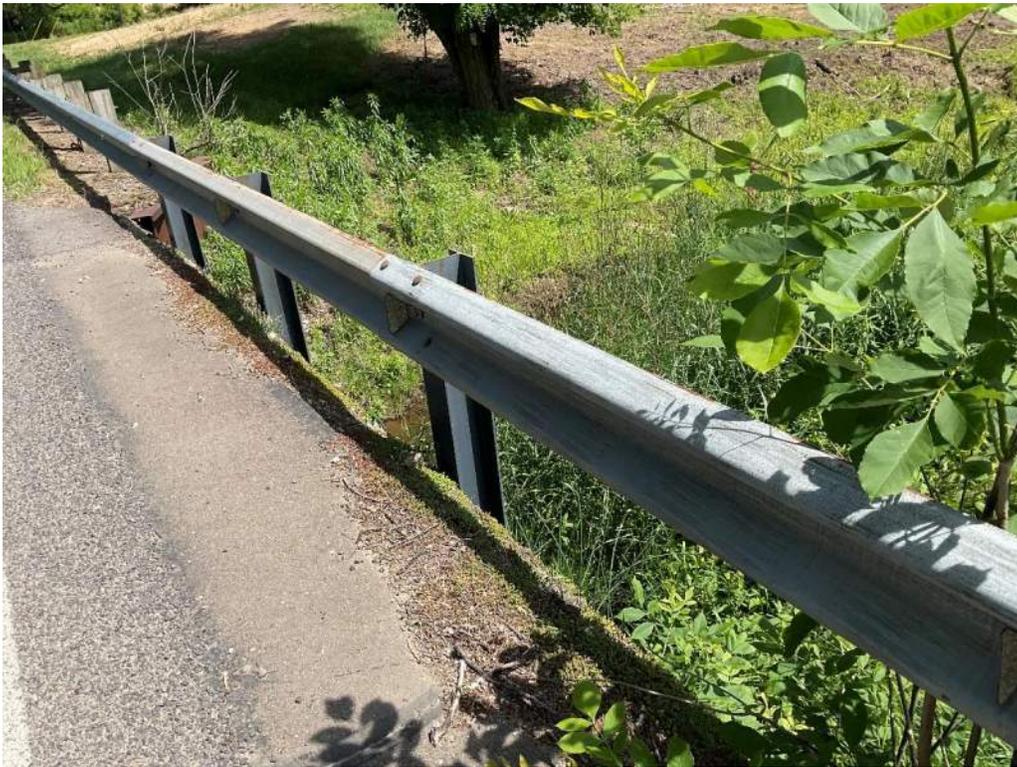
Railing along Snover Road Bridge

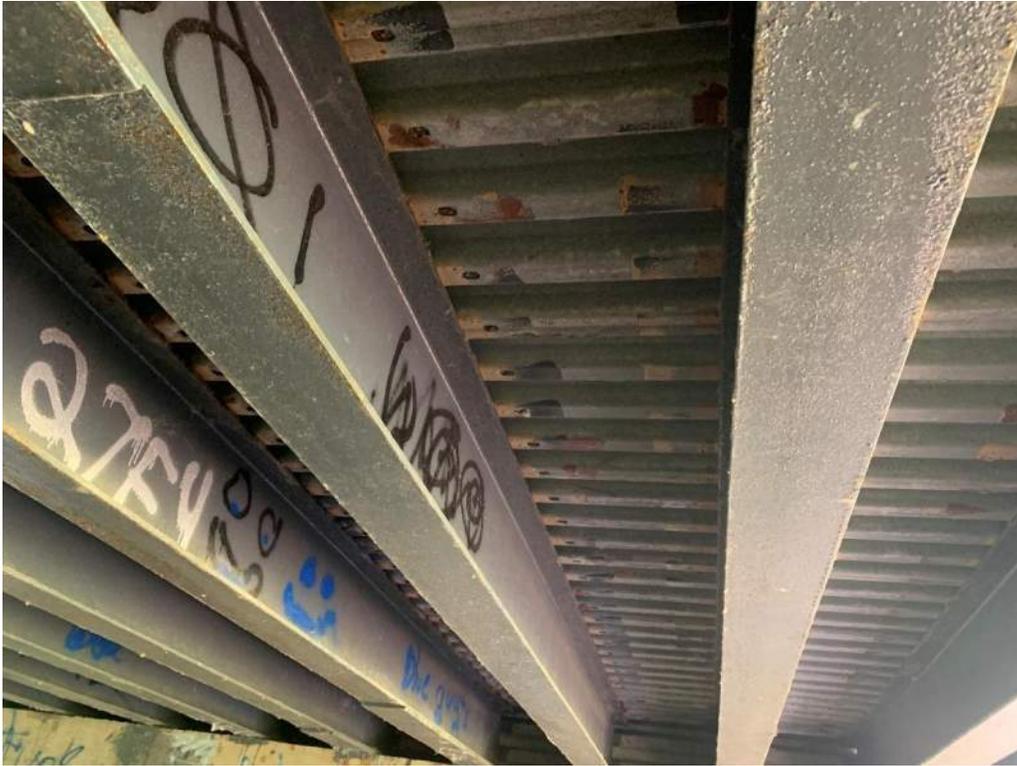
Deck bottom surface

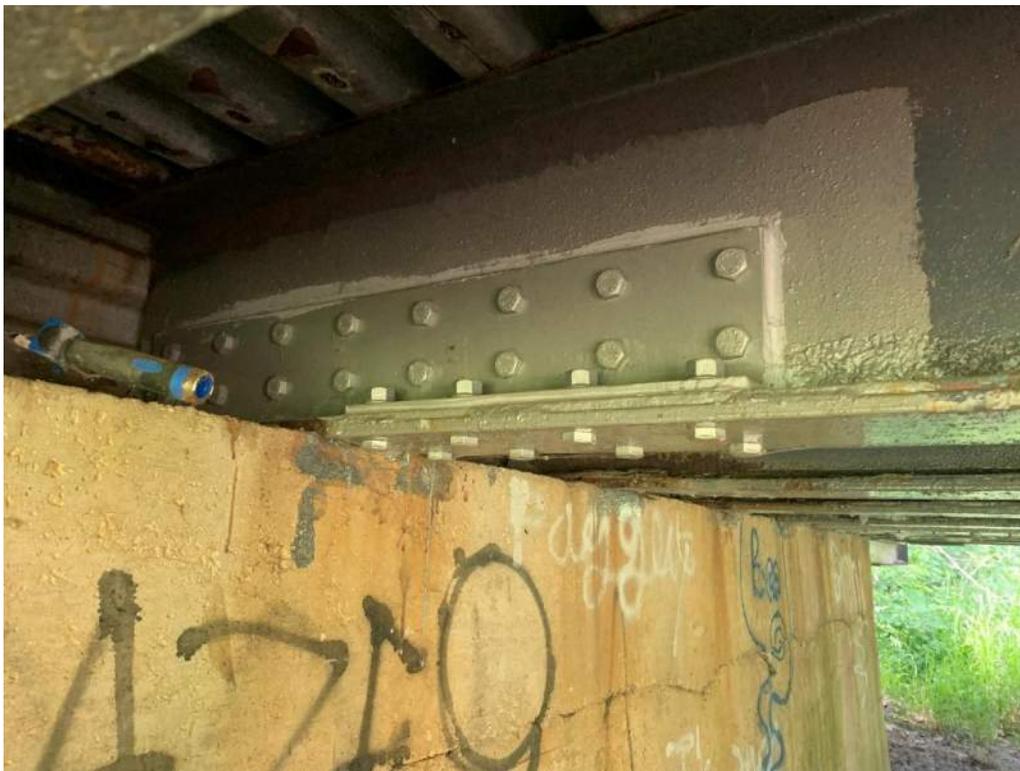
Beam end repairs

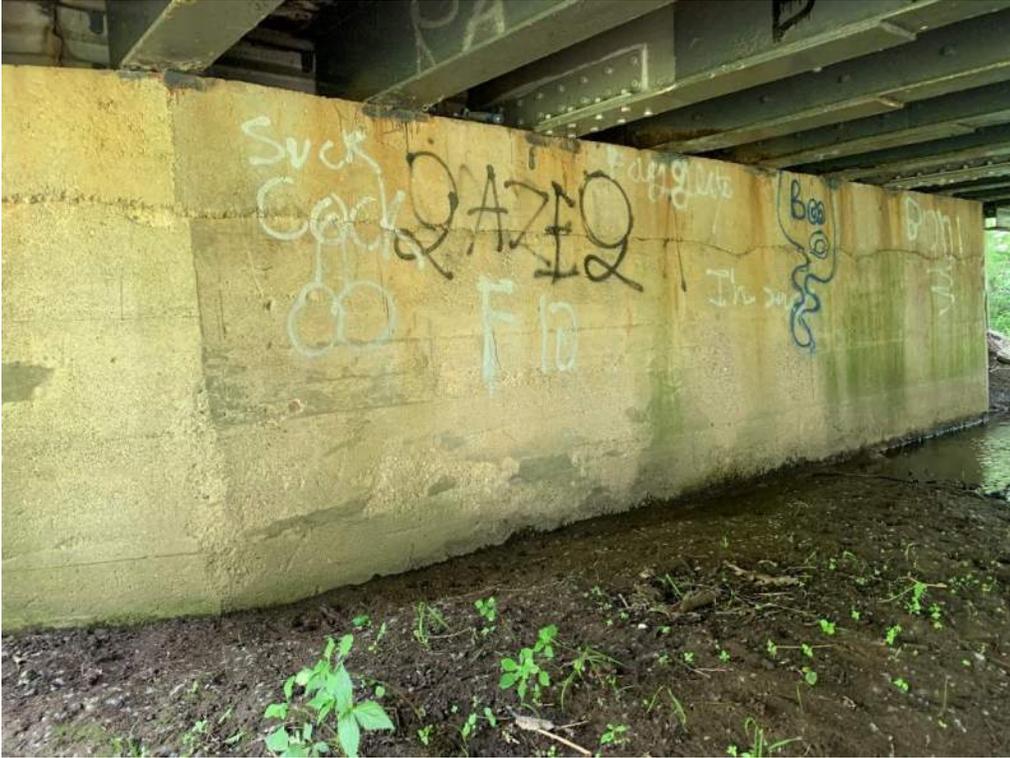
West Abutment

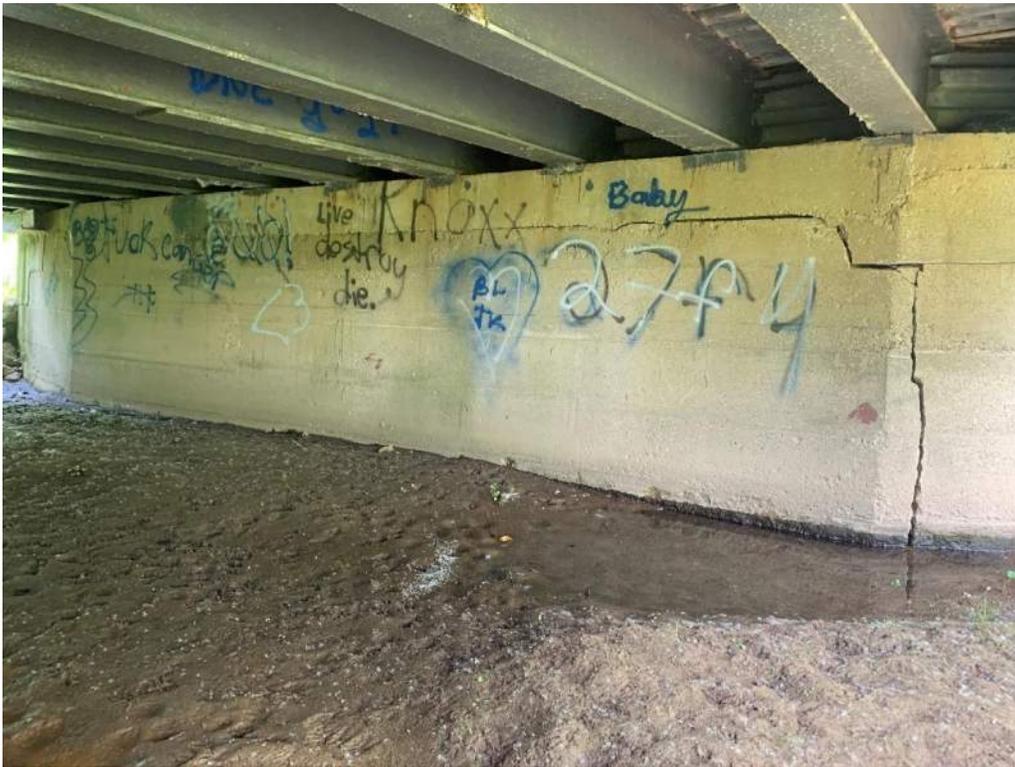
East Abutment

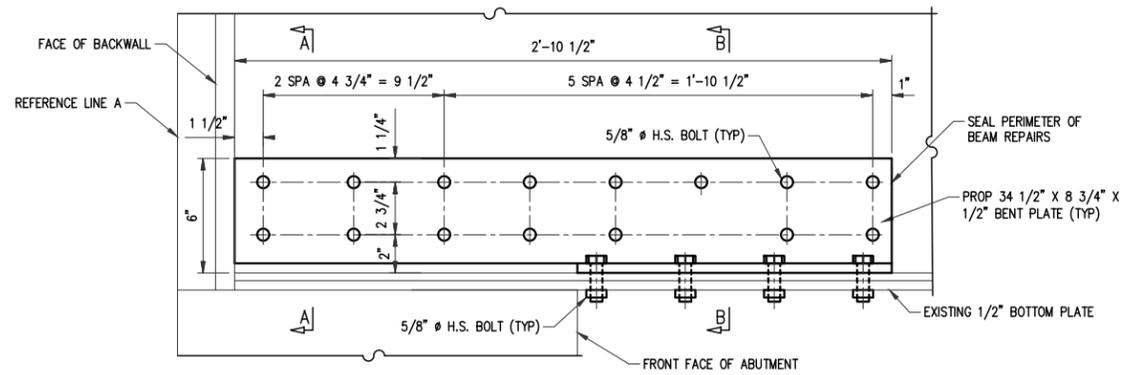
BOLTED REPAIR ELEVATION - WEB AND BOTTOM FLANGE
BEAM 5S NEAR WEST ABUTMENT

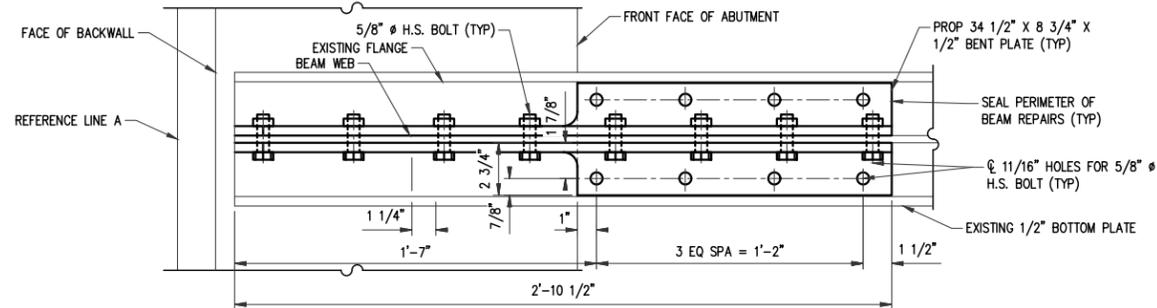
BOLTED REPAIR PLAN - WEB AND BOTTOM FLANGE
BEAM 5S NEAR WEST ABUTMENT

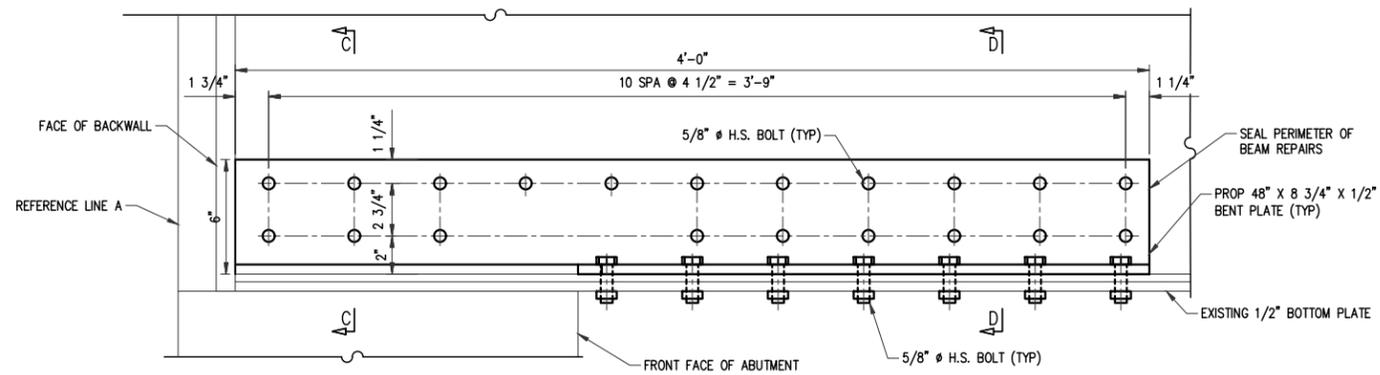
BOLTED REPAIR ELEVATION - WEB AND BOTTOM FLANGE
BEAM 9S NEAR WEST ABUTMENT

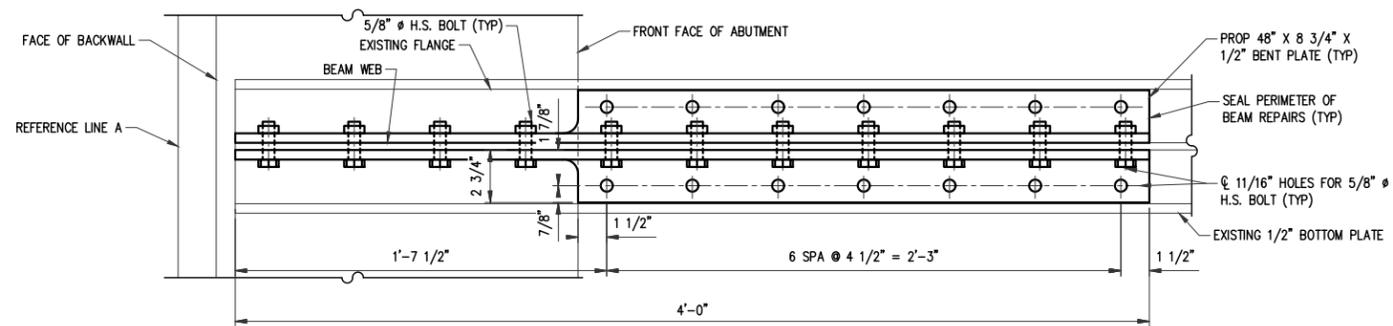
BOLTED REPAIR PLAN - WEB AND BOTTOM FLANGE
BEAM 9S NEAR WEST ABUTMENT

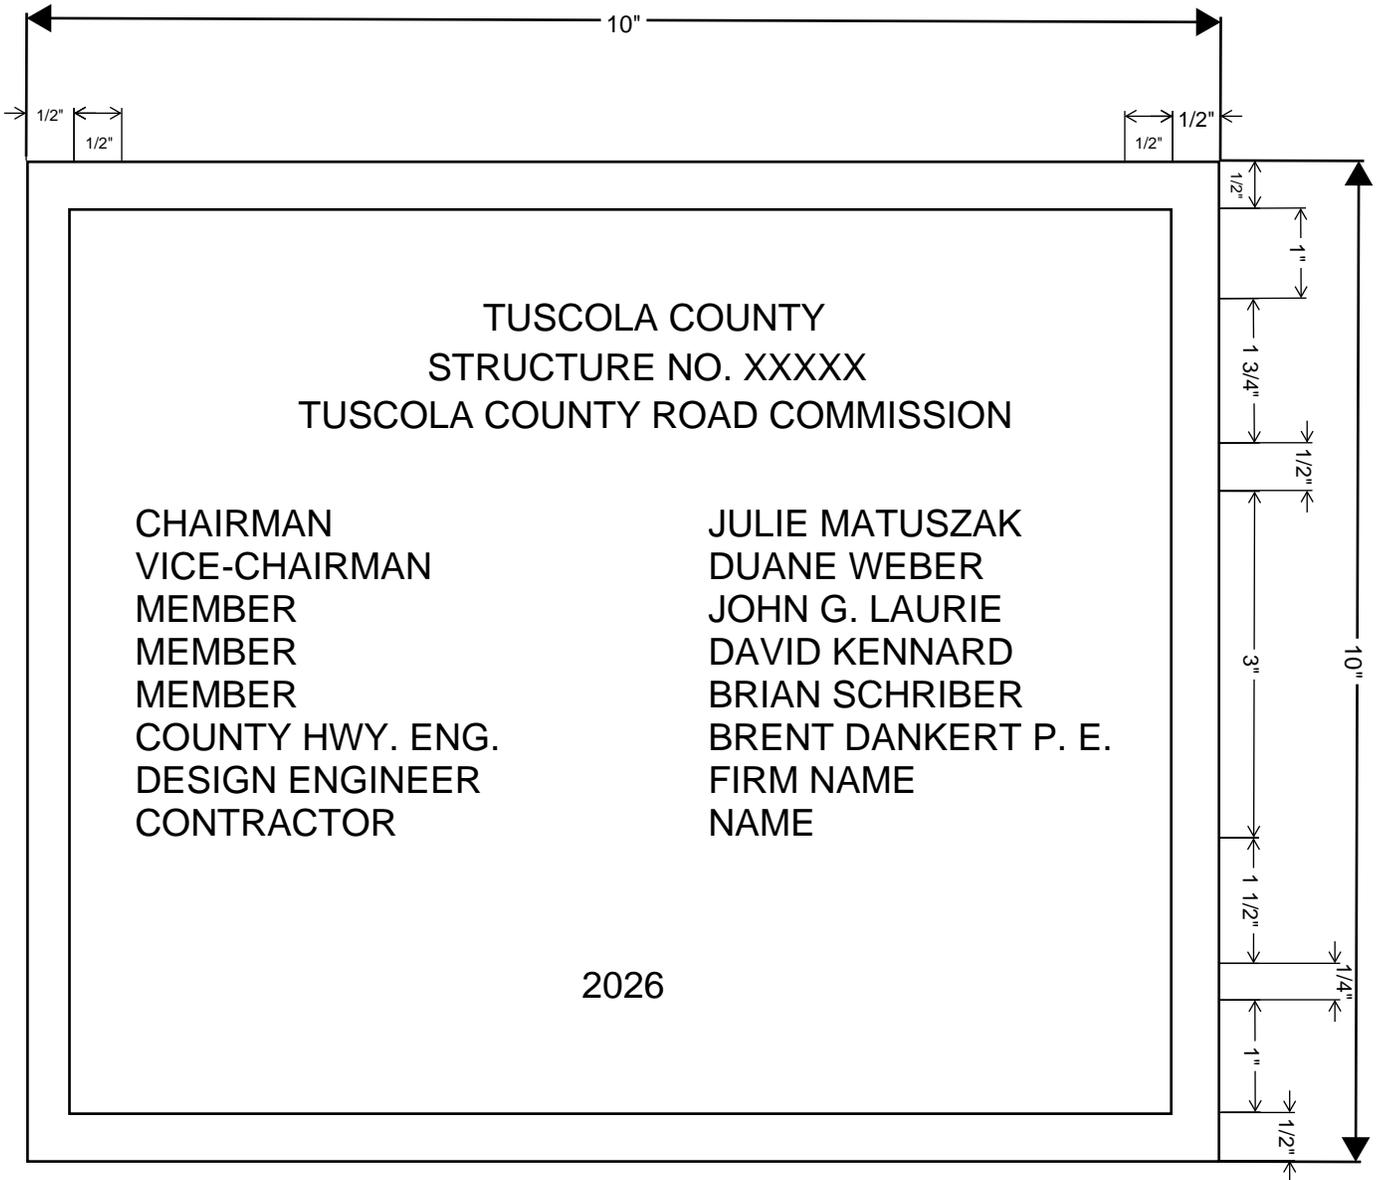
LETTER AND NUMBER SIZES ARE APPROXIMATE SLIGHT VARIATIONS FROM SIZE ARE ALLOWED.

PROVIDE (4) 3/8" DIAMETER L-SHAPED ANCHORS, MINIMUM 3" EMBEDMENT.
