**TUSCOLA COUNTY ROAD COMMISSION
REQUEST FOR PROPOSAL
PROFESSIONAL ENGINEERING AND BRIDGE DESIGN SERVICES
Hurds Corner over Sucker Creek Drain Bridge Design
Letting Date: September 28th, 2023**

Structure No 10511, Hurds Corner Road over the Sucker Creek Drain, Wells Township

BRIDGE SAFETY INSPECTION REPORT

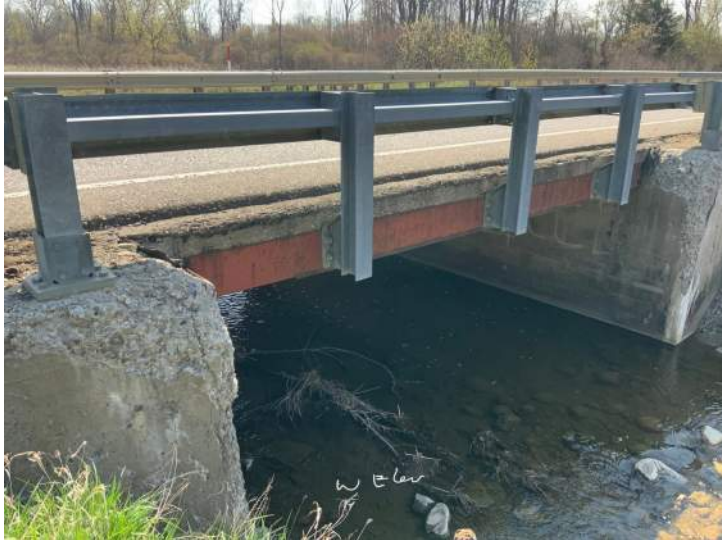
Document Name: IMG_6351.JPEG
Category: Elevation
Span Number:
Comments: West elevation

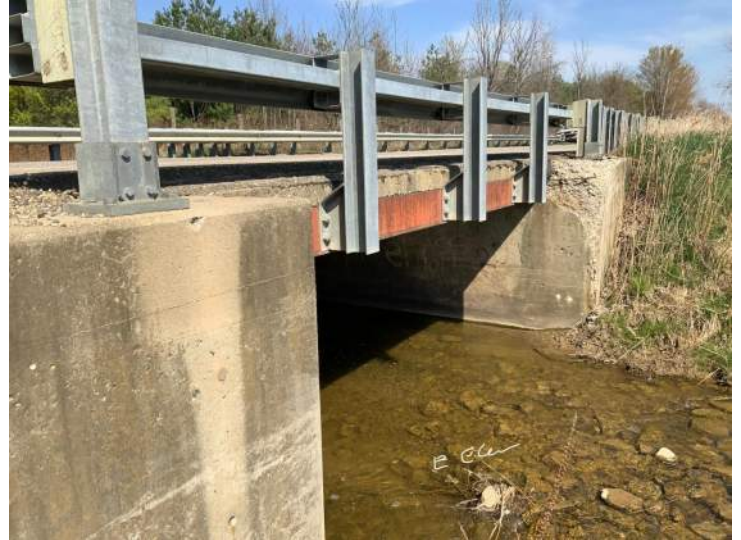
Document Name: IMG_6357.JPEG
Category: Elevation
Span Number:
Comments: East elevation

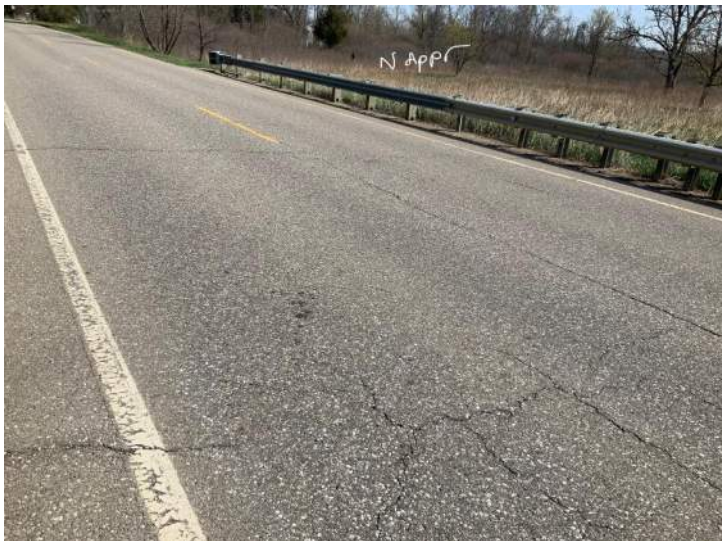
Document Name: IMG_6350.JPEG
Category: Approach
Span Number:
Comments: North approach

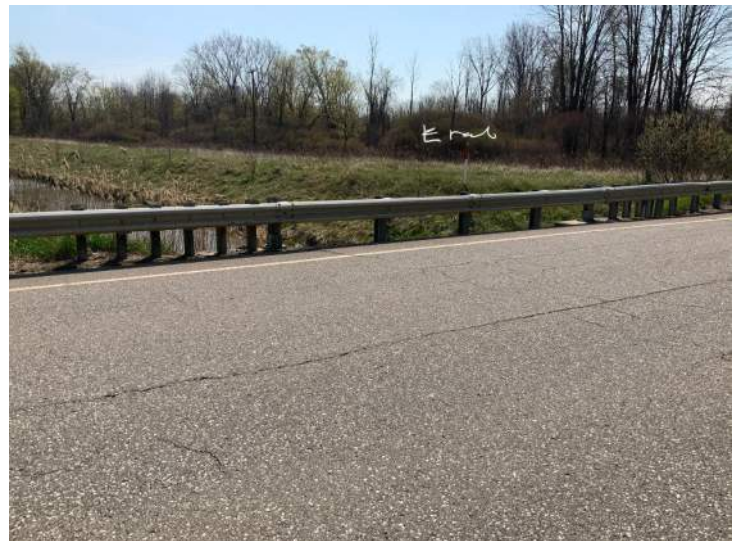
Document Name: IMG_6349.JPEG
Category: Railing
Span Number:
Comments: East rail

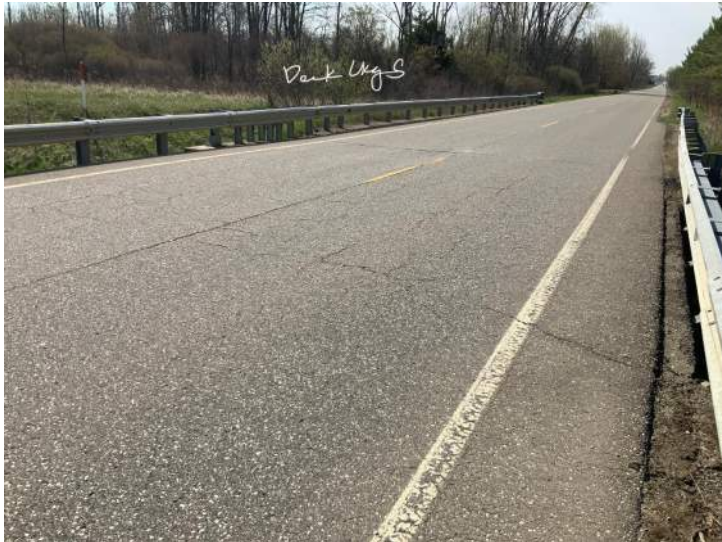
Document Name: IMG_6348.JPEG

Category: Deck

Comments: Deck looking south

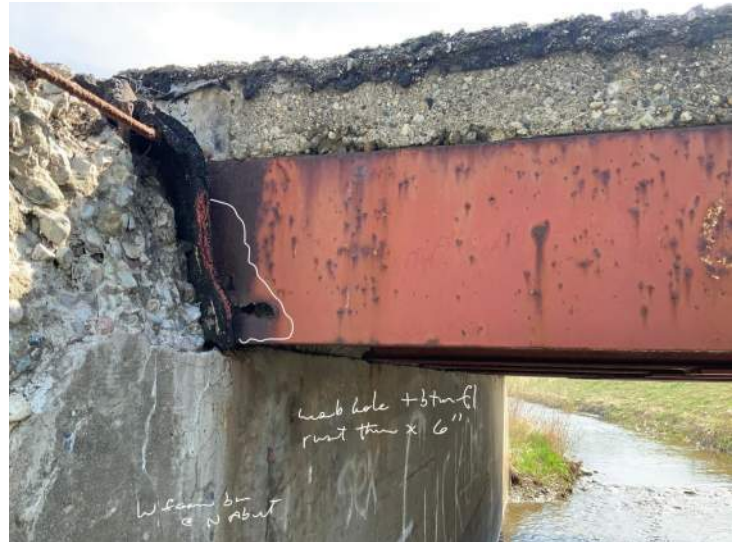
Document Name: IMG_6353.JPEG

Category: Superstructure

Comments: Beam 1W at north abutment

Load rate to account for fascia beam section loss (Vincent Guadagni 05/03/2021)

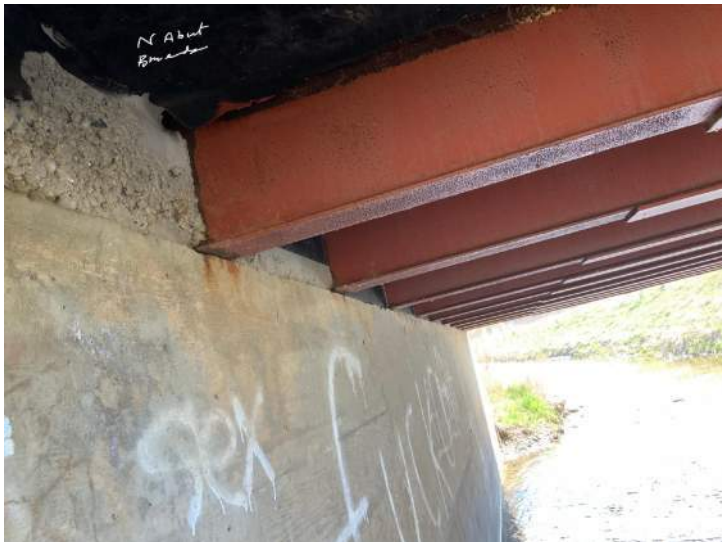
Document Name: IMG_6354.JPEG

Category: Superstructure

Comments: North abutment beam ends

Zone Paint	High	zone paint fascia beam ends after repair
		Super Repair	High	Repair fascia beam ends
		Substr Repair	High	Patch abutment/return wall spalls
		Other	High	Load rate to account for fascia beam section loss

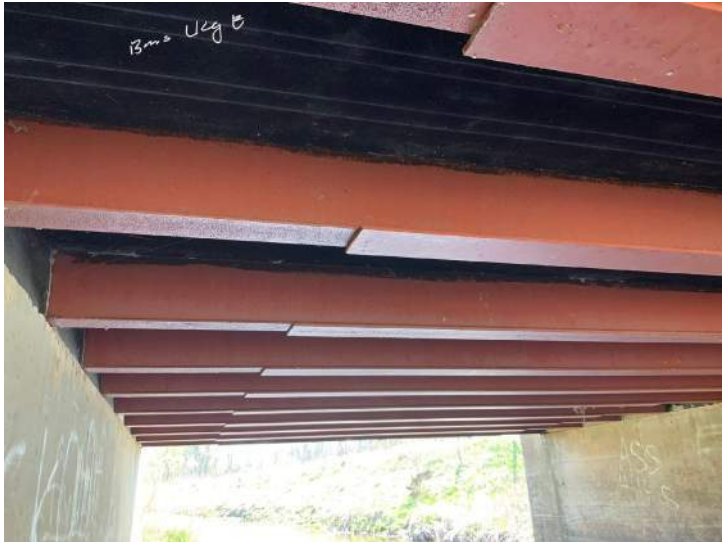
Document Name: IMG_6356.JPEG

Category: Superstructure

Comments: Beams looking east

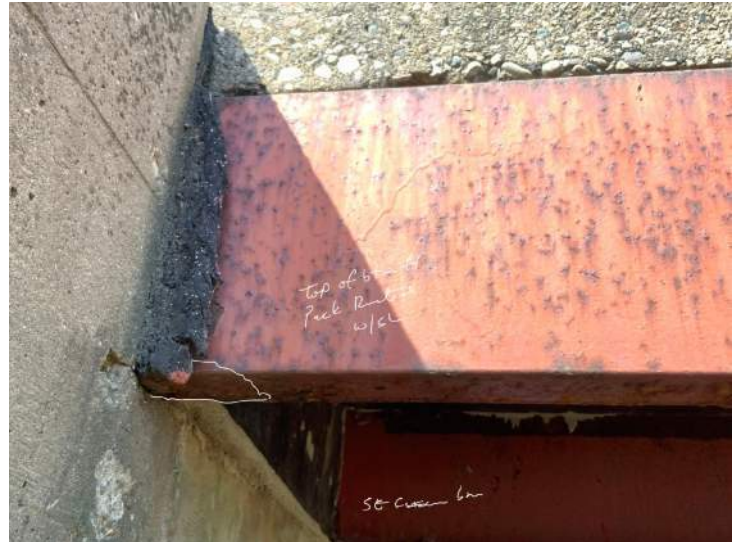
Document Name: IMG_6360.JPEG

Category: Superstructure

Comments: Beam 11W (east fascia beam) at south abutment

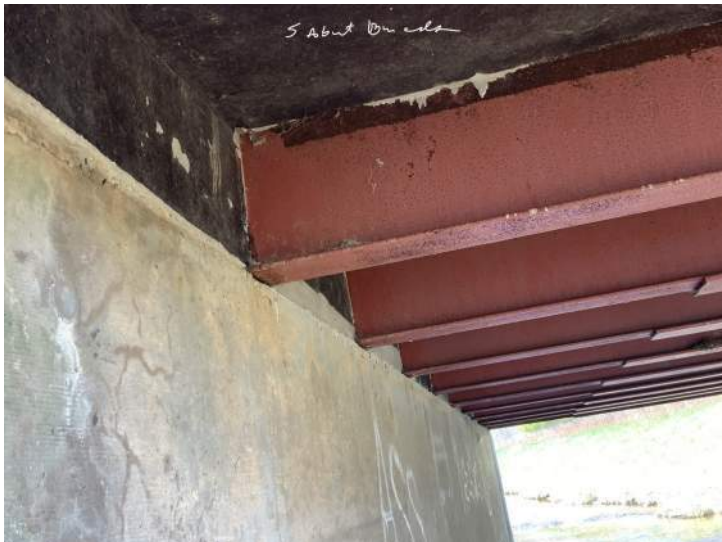
Document Name: IMG_6361.JPEG

Category: Superstructure

Comments: South abutment beam ends

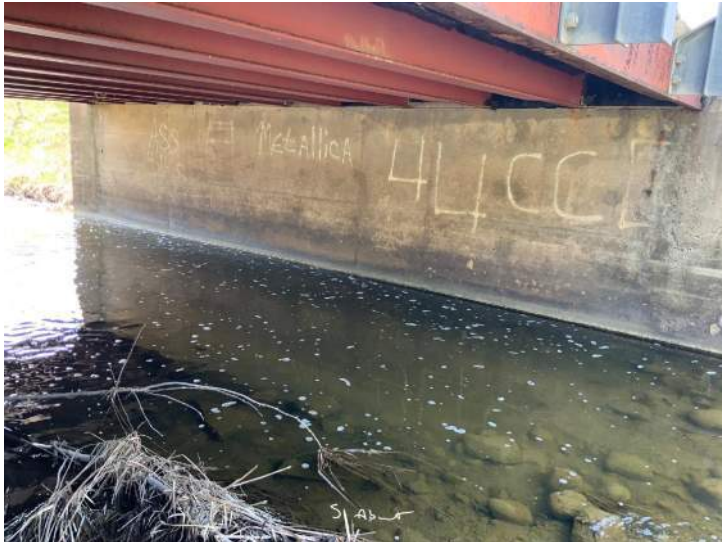
Document Name: IMG_6352.JPEG

Category: Substructure

Comments: South abutment

Recommendation Type	Priority	Description
Scour Repair	M	Install riprap at south abutment to address footing exposure.
Slope Repair	L	Repair erosion in south quadrants.
Deck Patching	M	Seals cracks in HMA.
Zone Paint	H	zone paint fascia beam ends after repair
Super Repair	H	Repair fascia beam ends
Substr Repair	H	Patch abutment/return wall spalls
Other	H	Load rate to account for fascia beam section loss

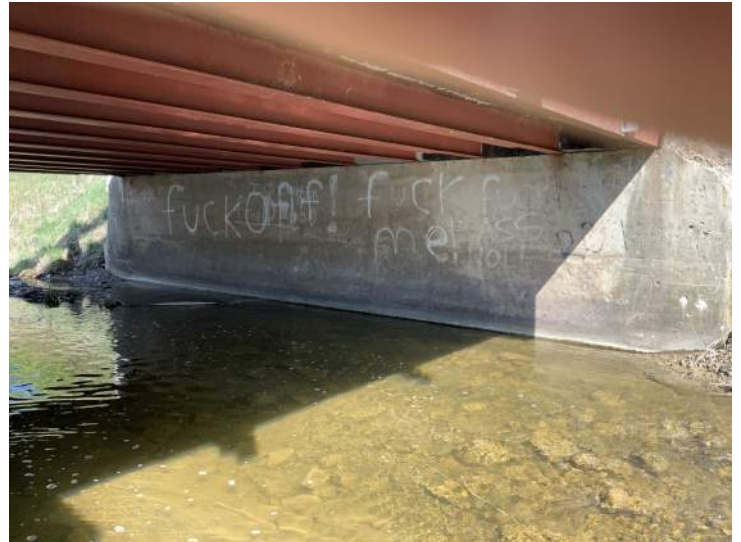
Document Name: IMG_6358.JPEG

Category: Substructure

Comments: North abutment

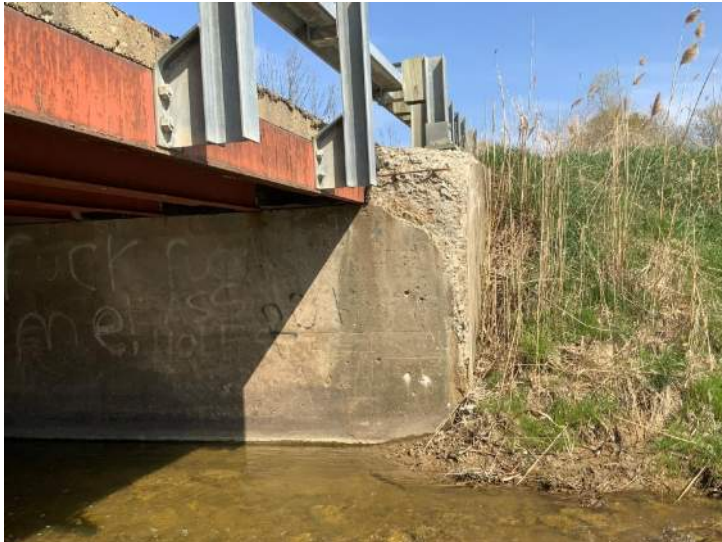
Document Name: IMG_6359.JPEG

Category: Substructure

Comments: East end of north abutment

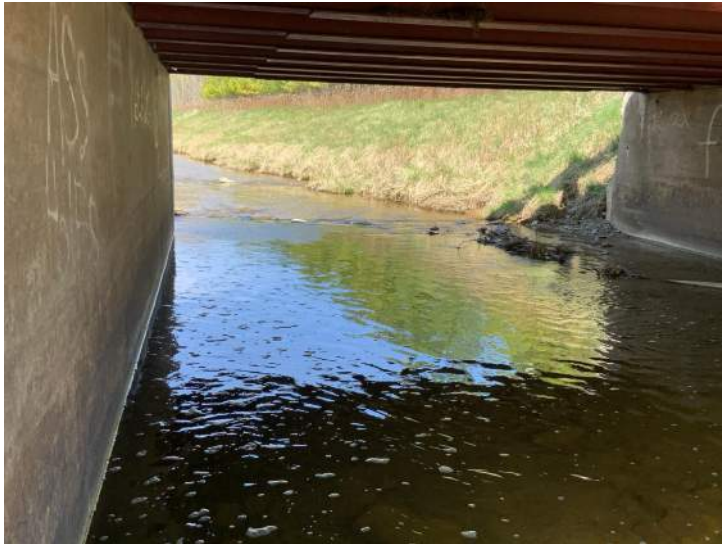
Document Name: IMG_6363.JPEG

Category: Channel

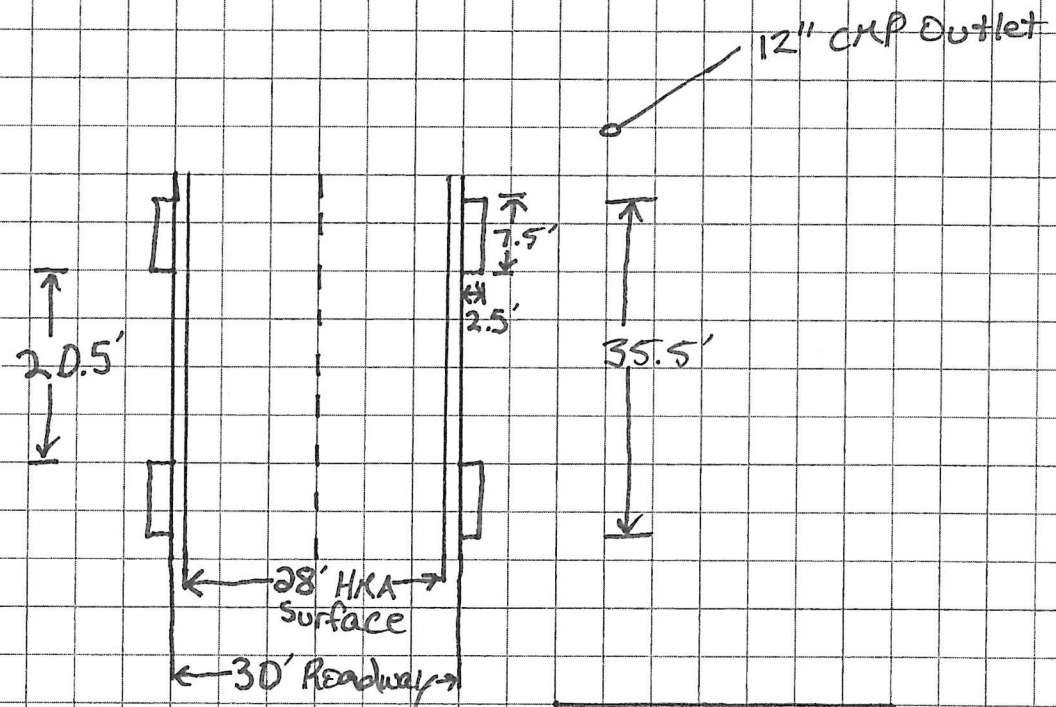
Hurds Corner over Sucker Creek Drain

Notes:
Possible Fiber
on site.
HMA has been
chipped and
sealed.
